**CROYODN ROAD RECREATION GROUND
THE McCALLUM & HOPE BANDSTAND c.1891?
PROPOSED RESTORATION WORKS**

**FINDINGS OF INITIAL INVESTIGATION
AND PRELIMINARY BUDGET INFORMATION**

NOVEMBER 2013

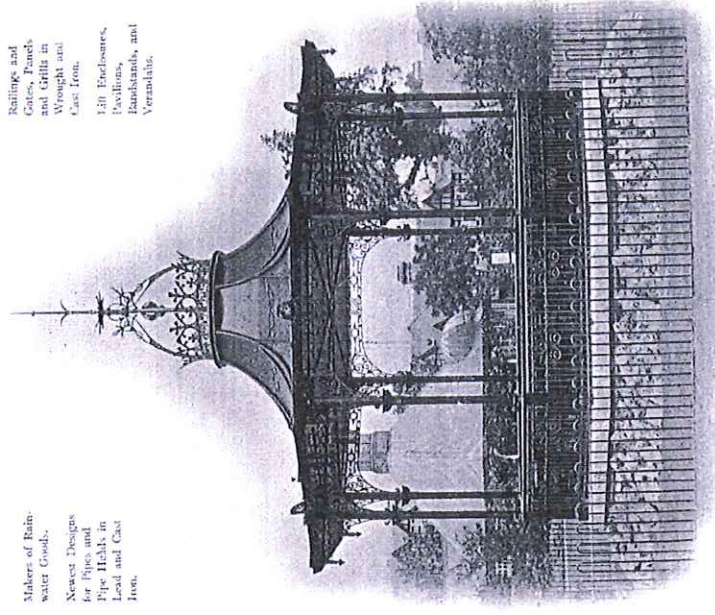
Possible 1891 – 1909 dates given. Antefix detail
in evidence in original design.

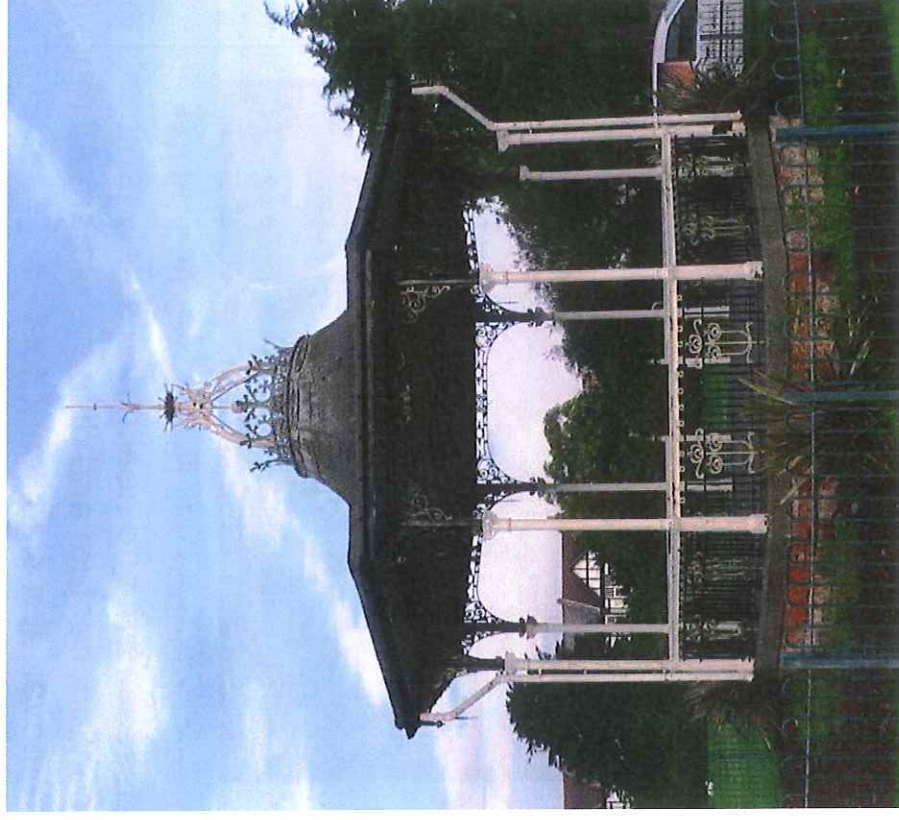
2013. Partially restored in in-appropriate materials.
Antefix detail lost. Secondary guttering applied

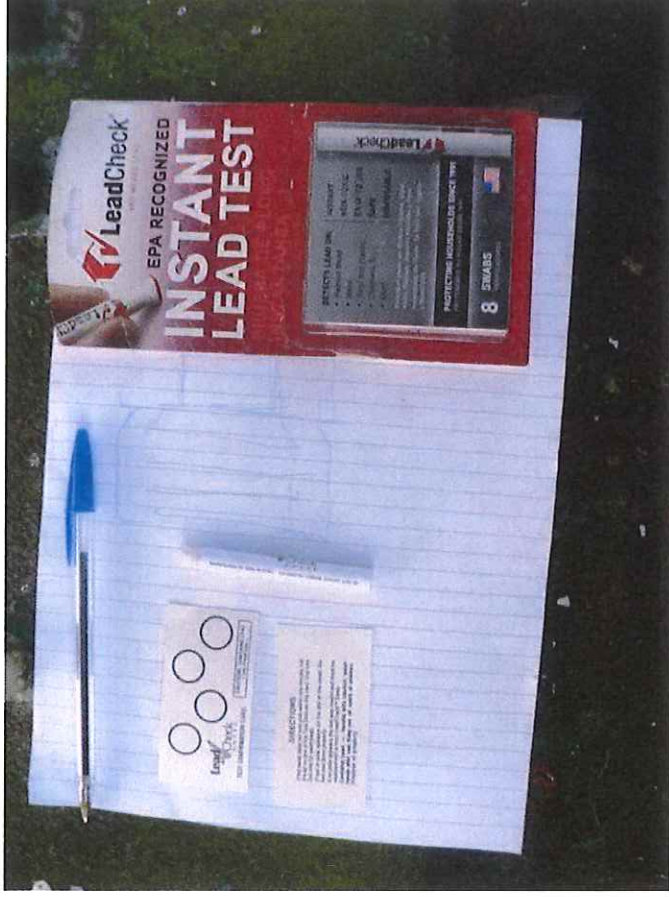
Paint and surface was tested in three areas and tests proved positive for lead in all cases.

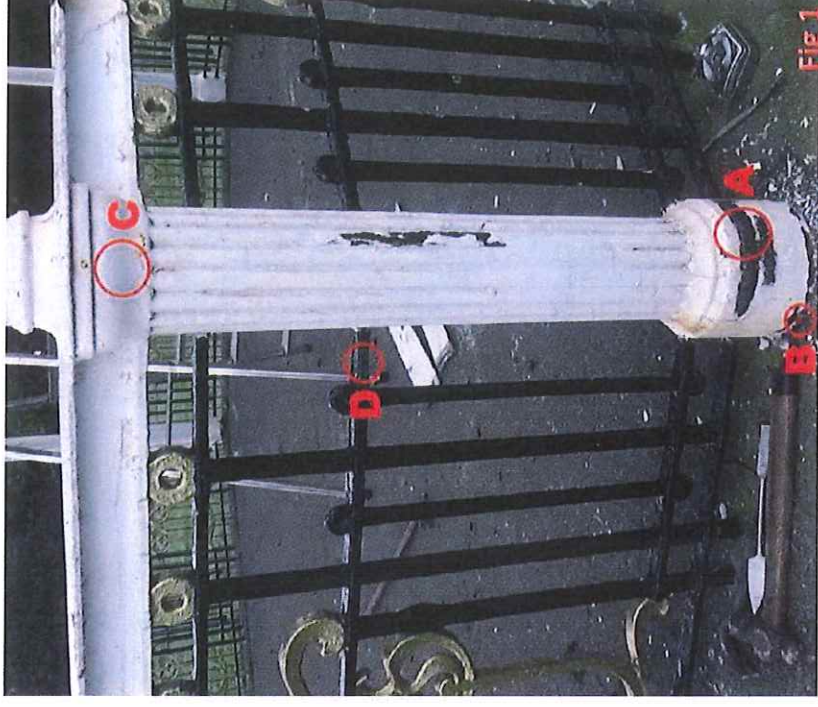
Lead presence will require additional risk assessment and health and safety protocols to contain, capture and dispose of harmful material on removal, at a significant cost.

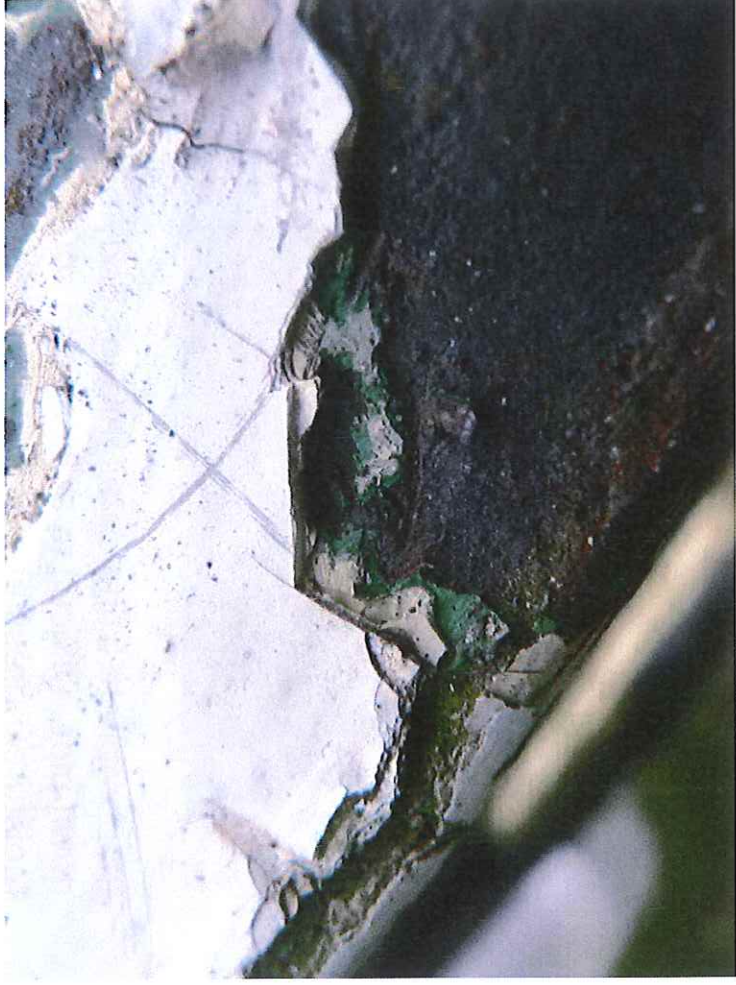
Handrail paint layers in close up. Evidence of early Green layers under cream and white coats.

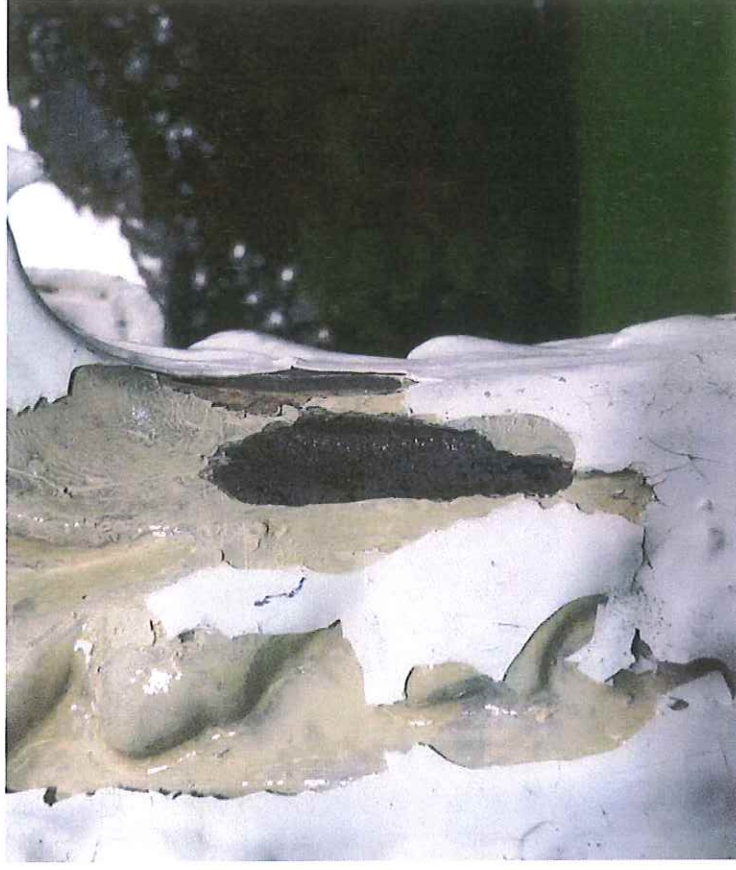
Composite capital paint layers in close up. Evidence of early dark Green layers under cream and white coats. Lead paint (Cream) below Acrylic (White)

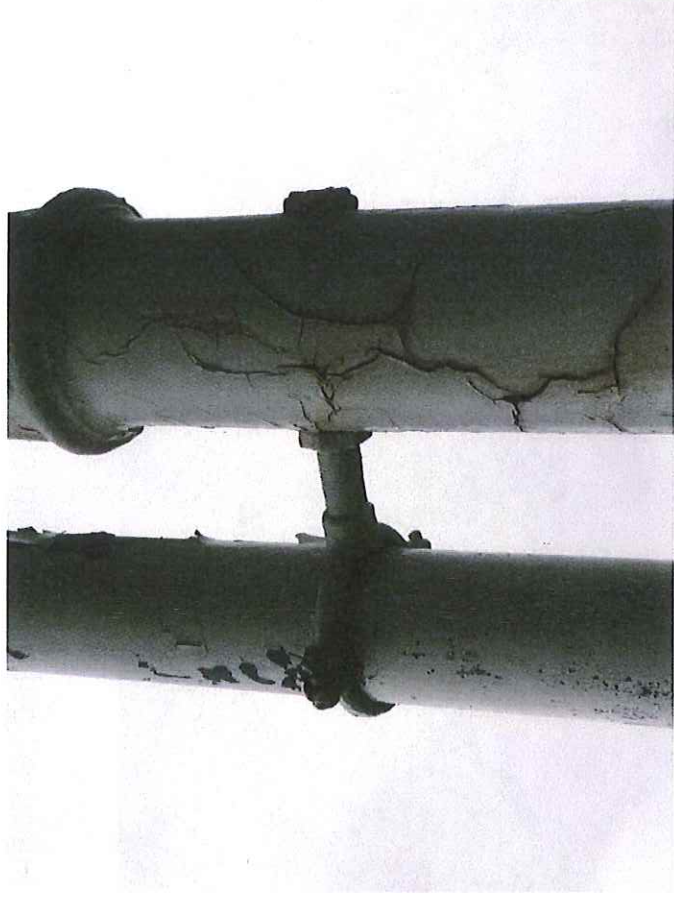
Inappropriate fixing detail through body of cast down pipe. Difficult to achieve and source of moisture ingress and potential freeze thaw action and mechanical damage to the downpipe.

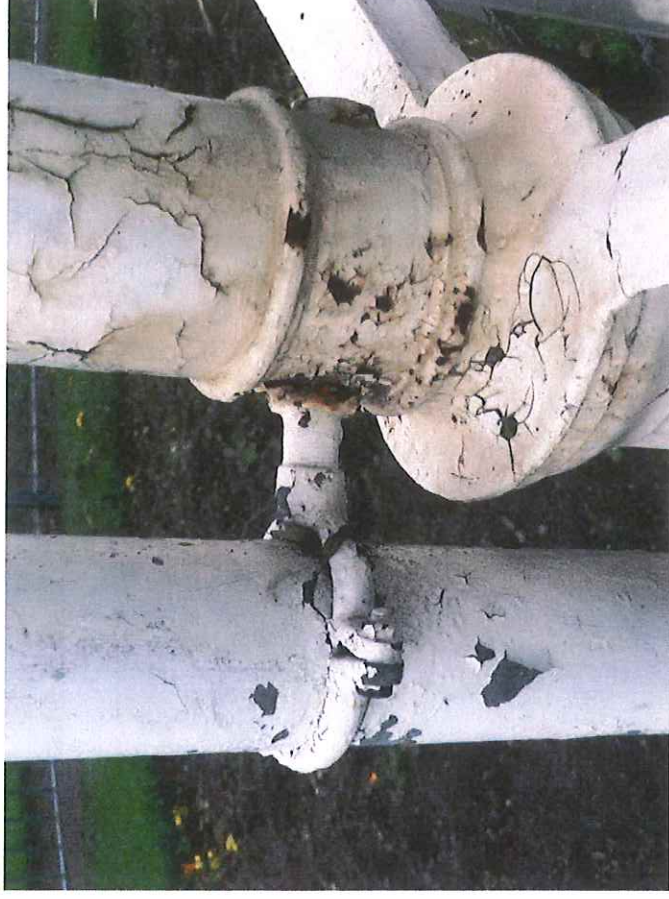
Inappropriate fixing detail through body of cast down pipe. Connection to handrail under threat. Should be removed and made good.

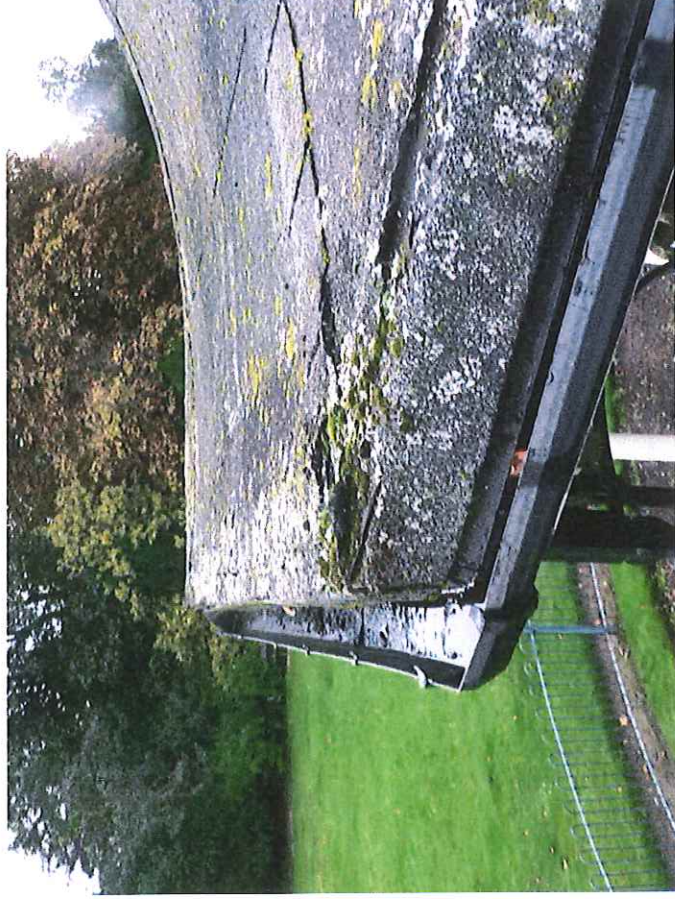
Gutter line altered in the past. Early evidence suggests ogee shaped gutter with higher sides and Antefix Palmette detail to centres. Mounting position for gutters altered, timber removed at an earlier date.

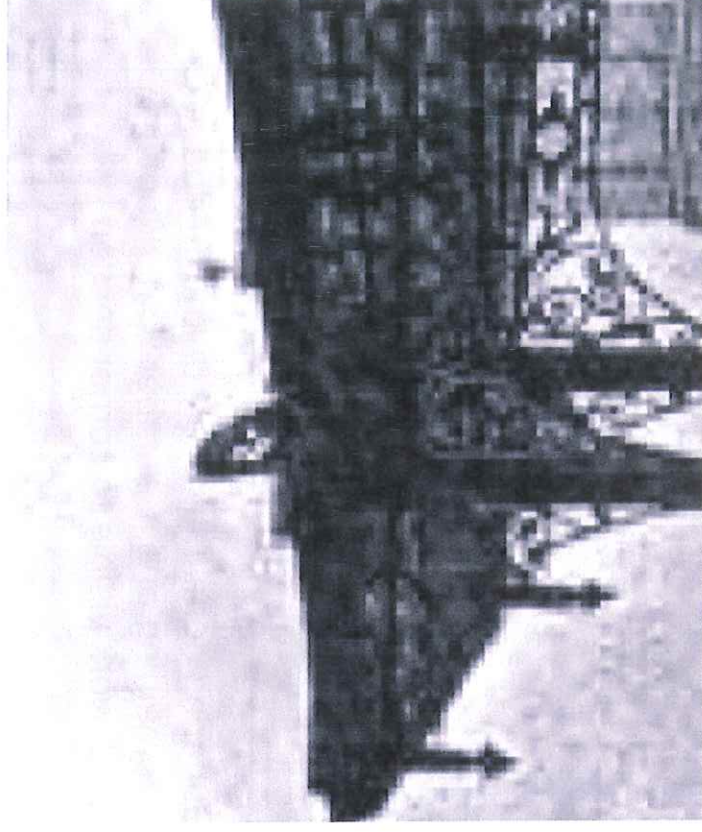
Lead rolls present above gutter line. Antefix detail to centre creasting. No external downpipes.

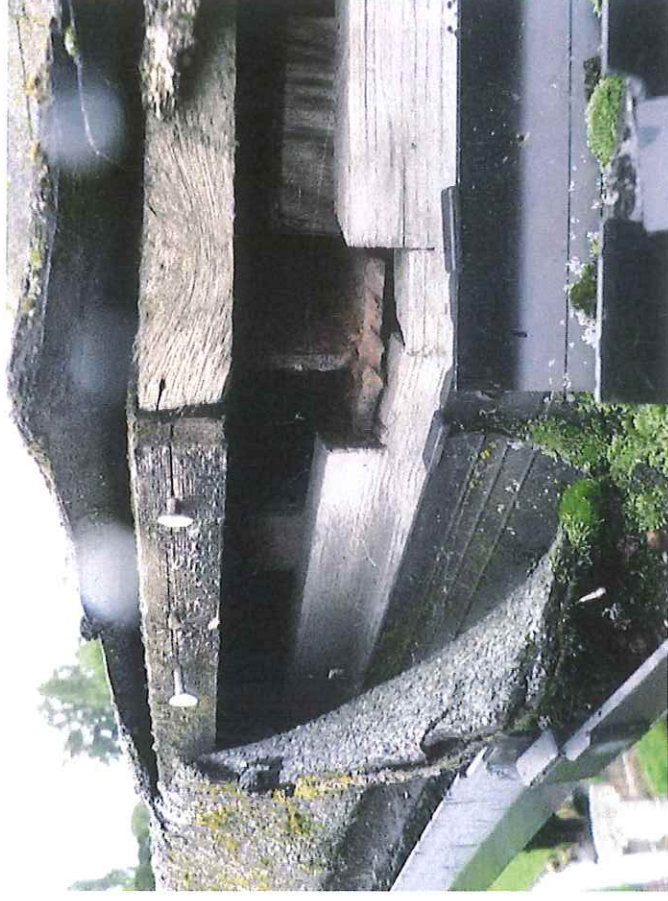
Guttering detail ultimately unknown due to lack of remaining original timber work. Roof iron frame work visible to corner section.

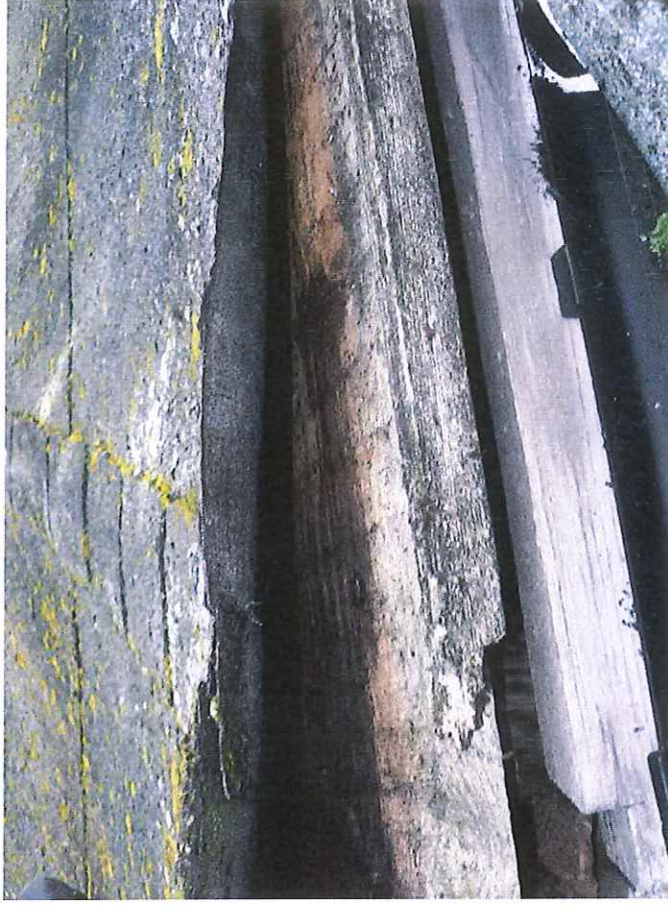
Low quality roofing felt laid directly onto timber boarding. Timber work damage not excessive where exposed.

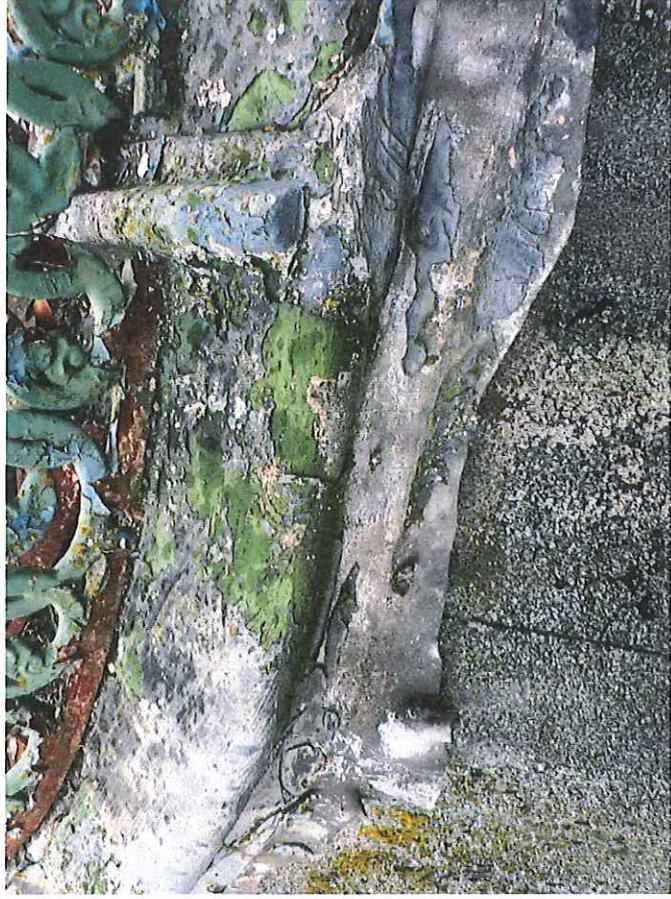
Remaining lead around seat to corona is original and has not been replaced. Evidence of Green paint coverings to seat but not main roof. Remnants of lead roll seen to the left.

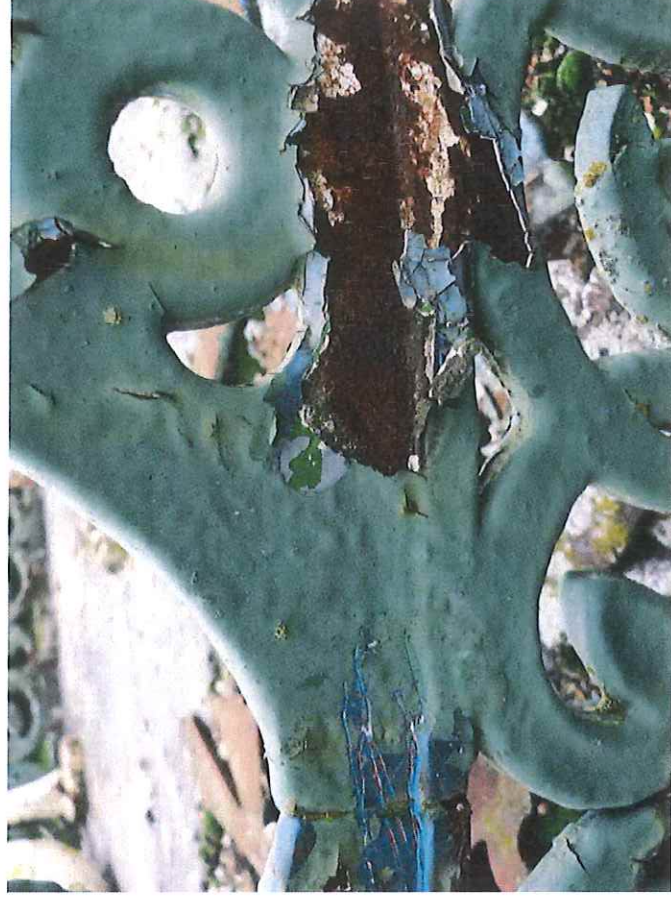
Corona evidence of light Green coating, then earlier light blue then earliest coat bright Green (seen in the centre of the image)

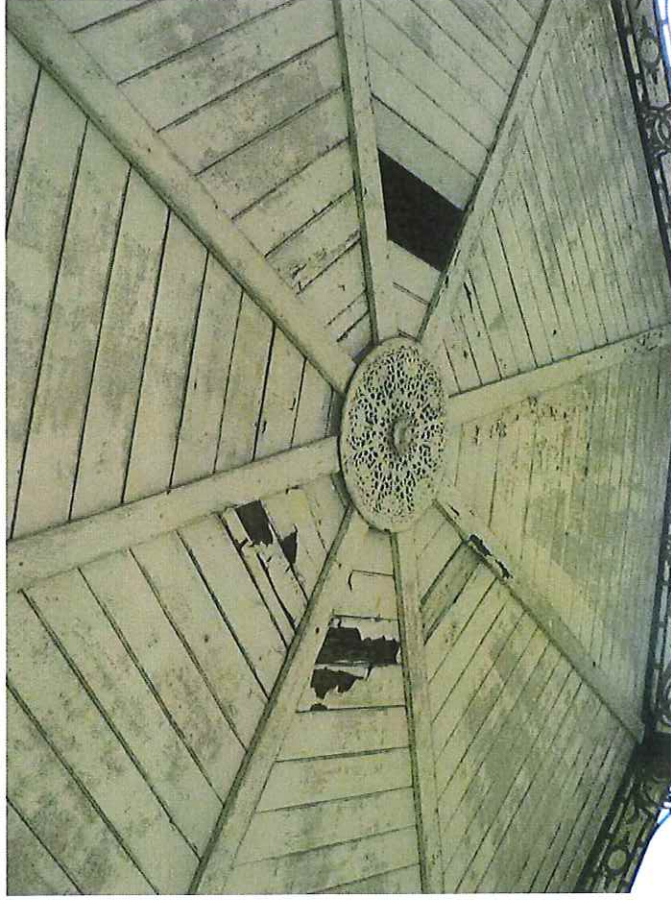
Soffit tongue and groove boards overall in good condition. Some replacement required. Many boards appear original

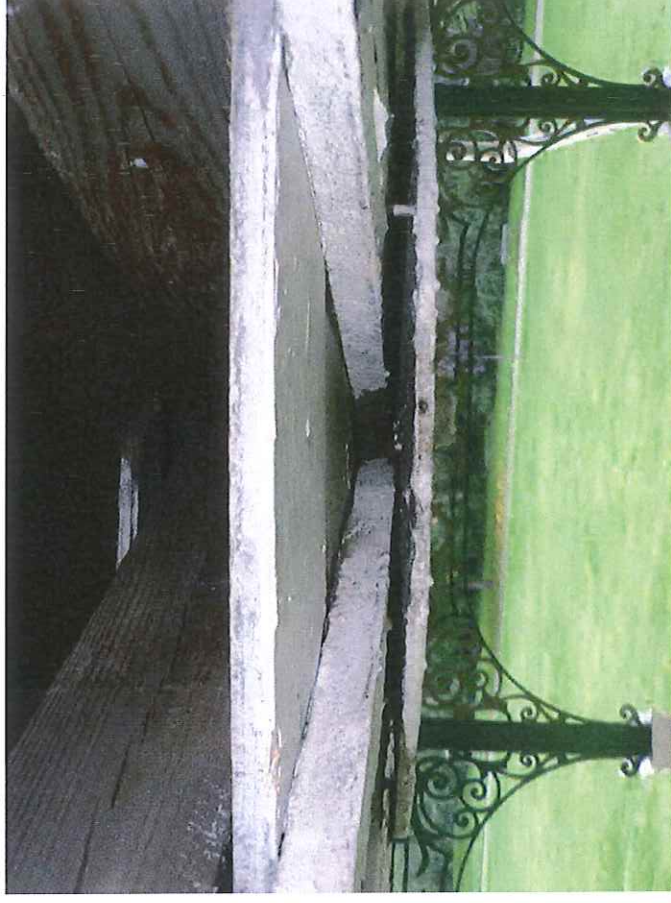
Major timbers above in good condition where exposed during investigation.

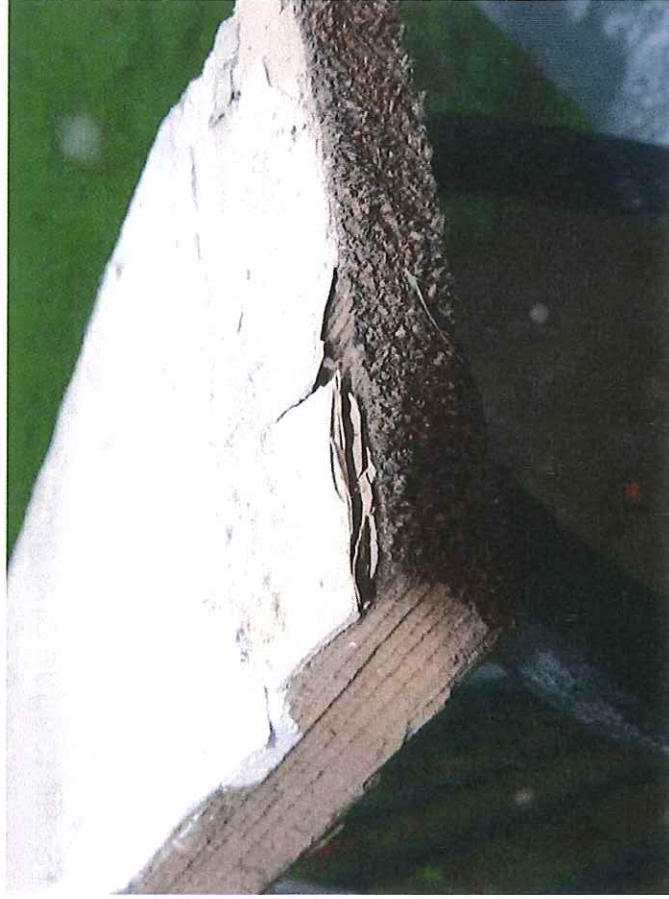
Soffit tongue and groove boards to soffit showing extensive paint layers over many years of application

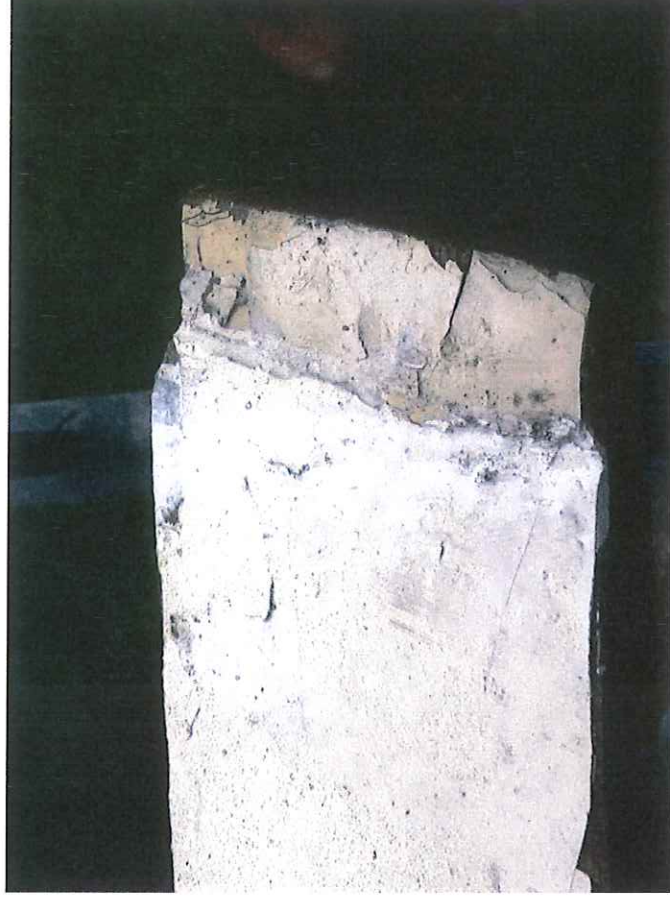
All paint layers visible under inspection exhibit light cream – dark cream colour. Lead paint expected but recovering possible with wet rubbing down

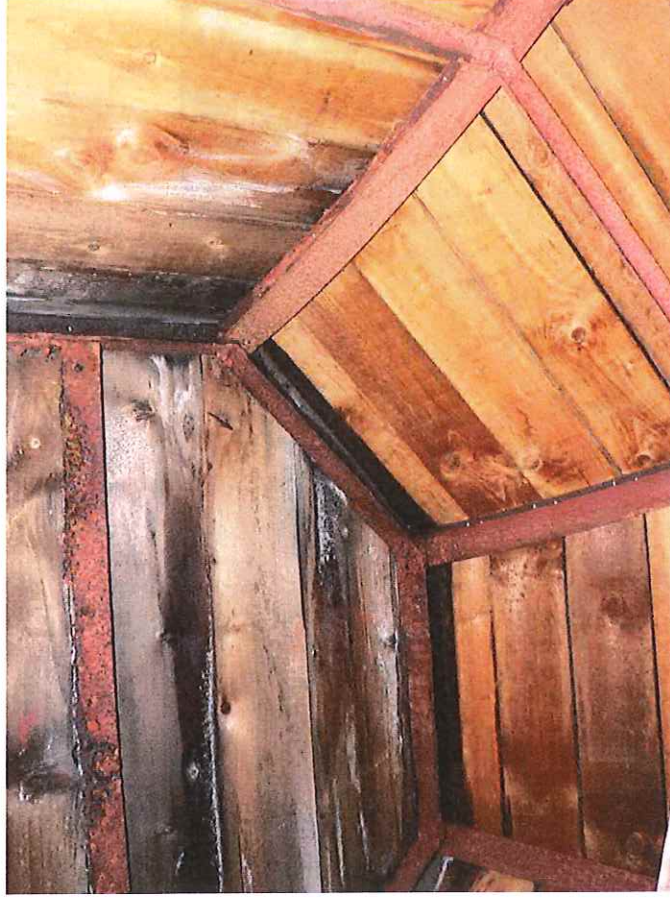
Roof boarding beneath felt has been replaced in recent years (within 20-30yrs), Self tapping non ferrous screws used to fix boarding to iron frame

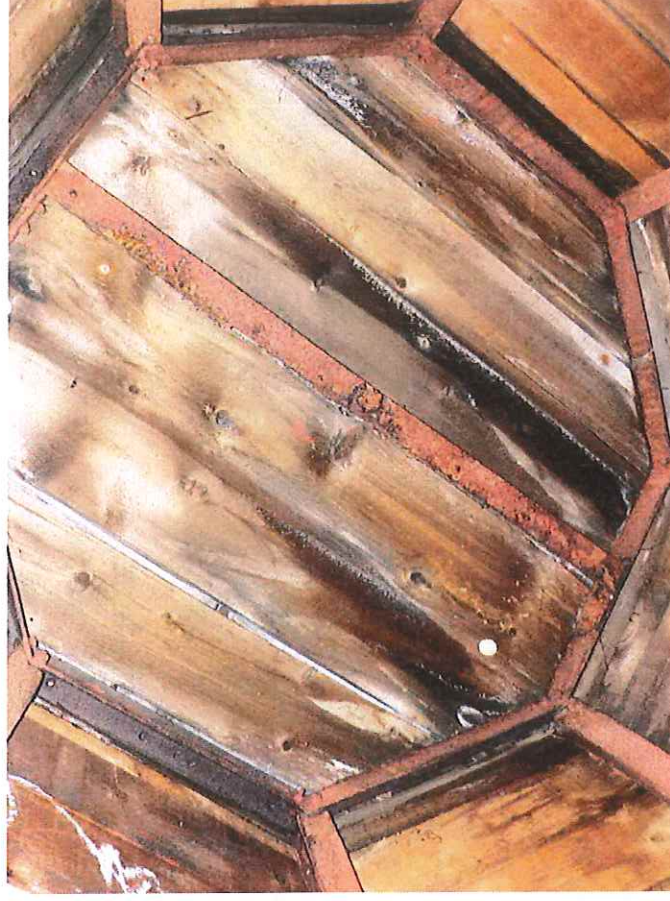
Area below Corona shows minor moisture ingress and retention but should stabilise following exposure and drying out. Majority of boarding can be used again. Some replacement will be required

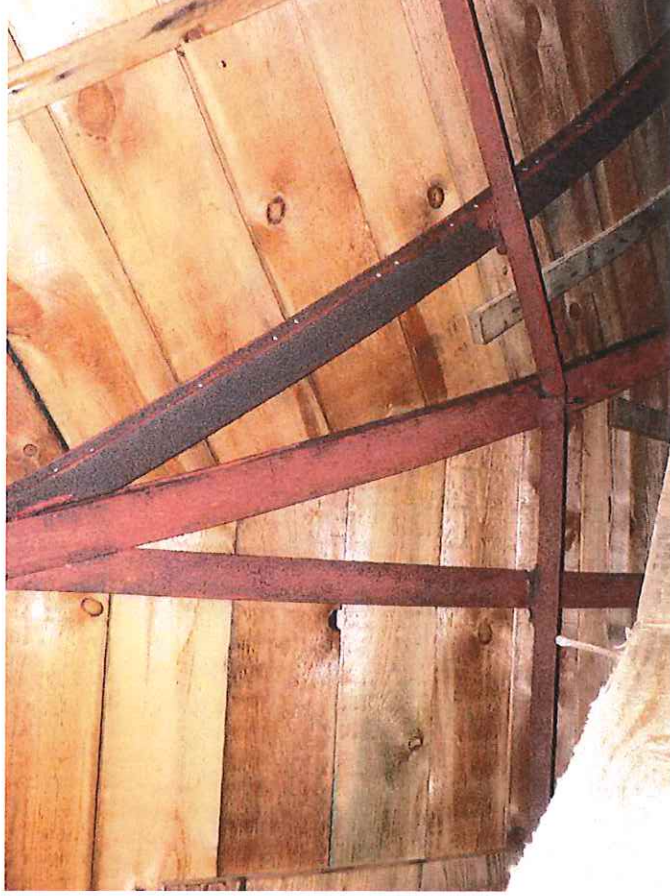
Iron frame work requires light abrasive clean and painting for protection in the long term.

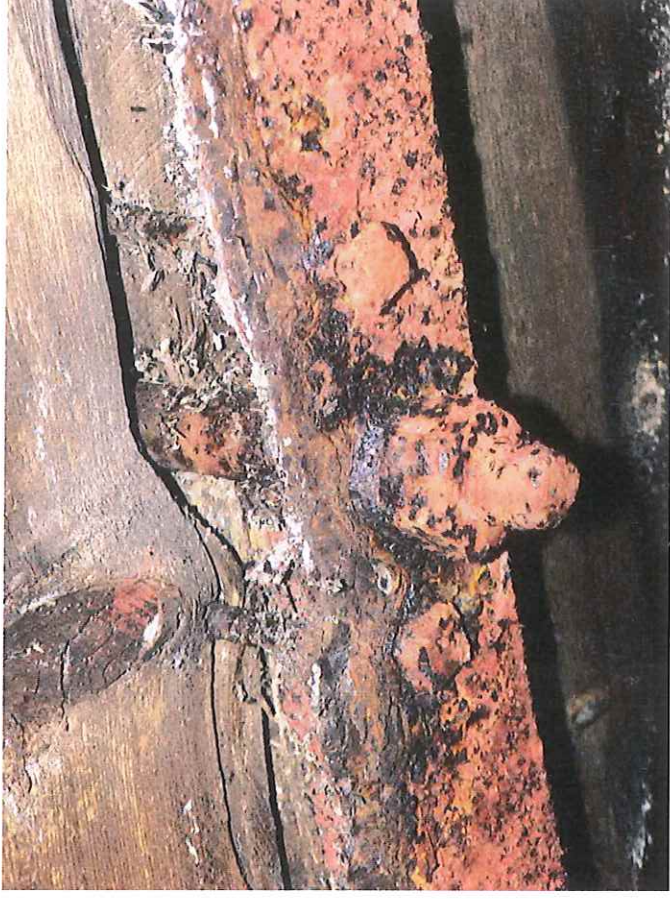
Iron support frame to Corona terminal showing evidence of corrosion to connecting rod and cross piece. Possible replacement to rod required.

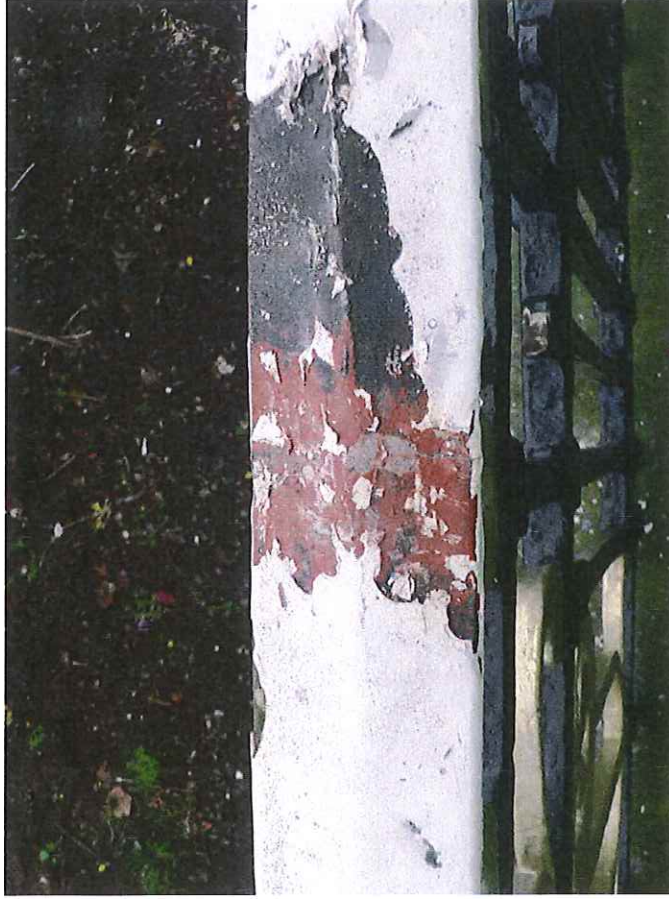
Hand rails have been cut and welded previously to all sides. Evidence of settlement historically. Some areas of previous poor repair will require cutting and re-welding

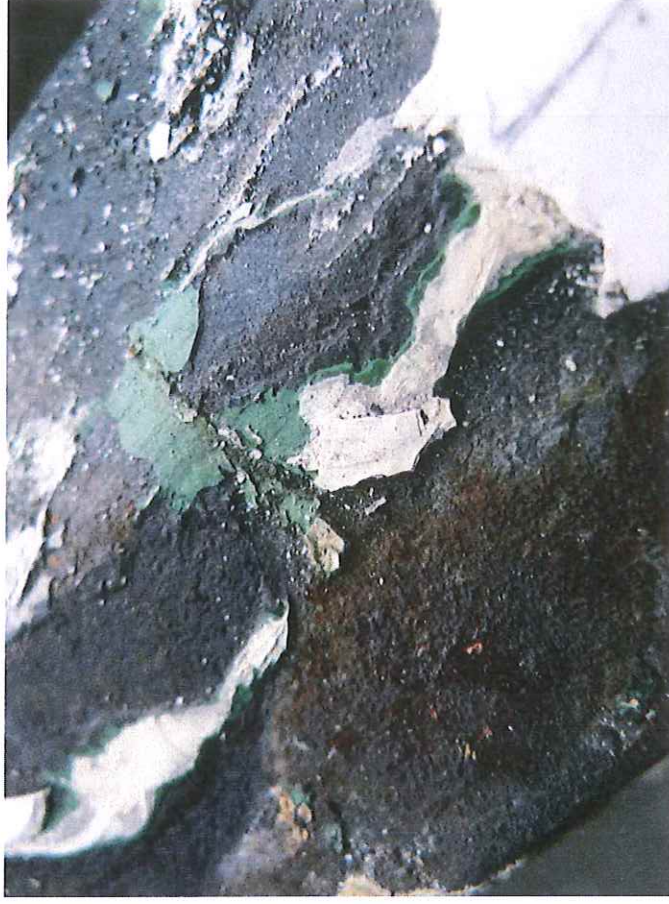
Build up of paint layers resulting in a loss of detail overall. Lowest paint layers are in evidence in a dark Green.

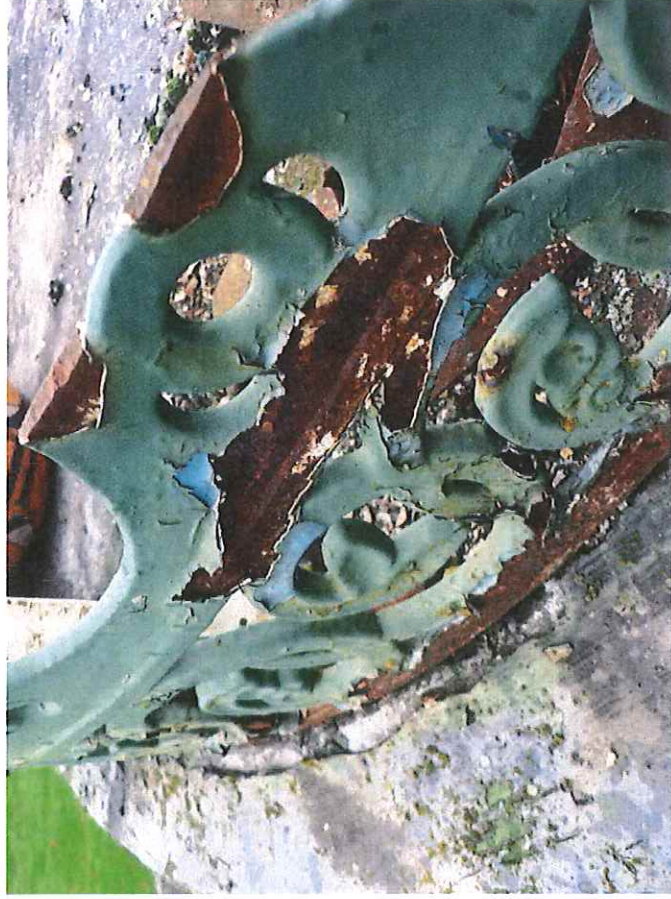
Extent of detailing lost through paint layers. No major corrosion to base.

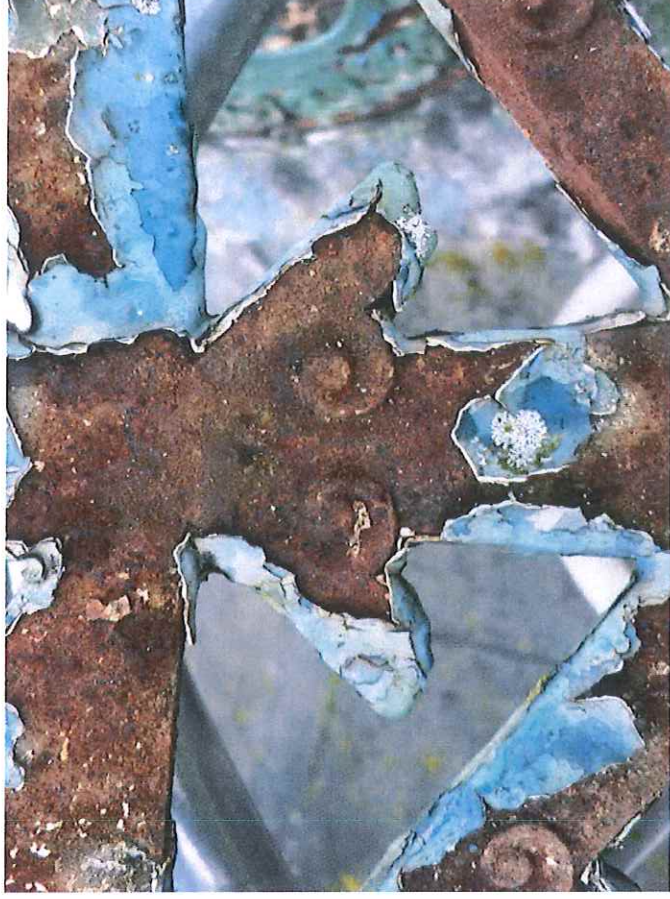
Floral volute detail of Corona previously lost under paint layering. Several pieces will require replacement and welding.

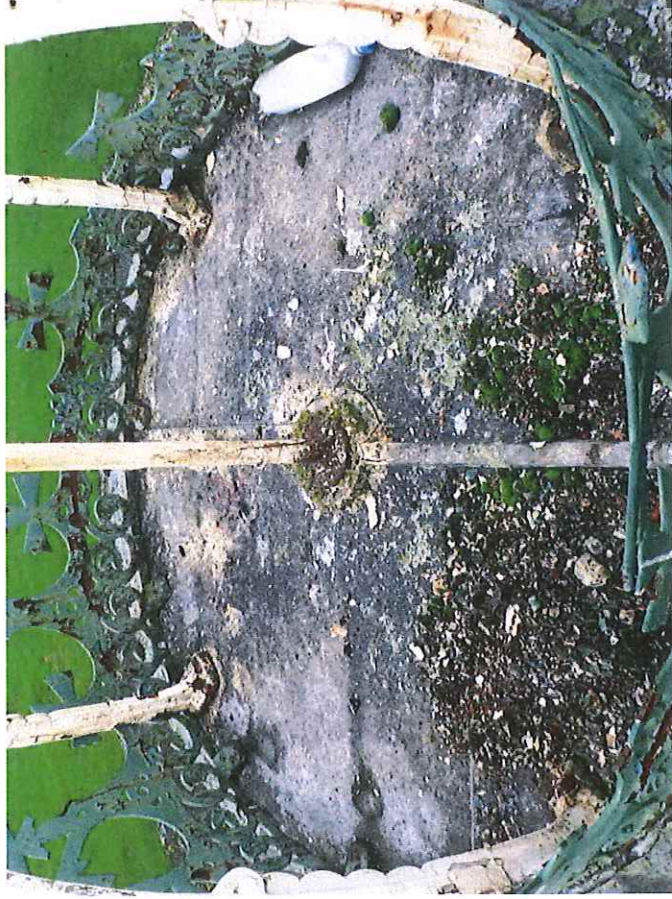
Lead protection poor. Perforated covering will allow direct penetration from rainwater onto iron work and timbers

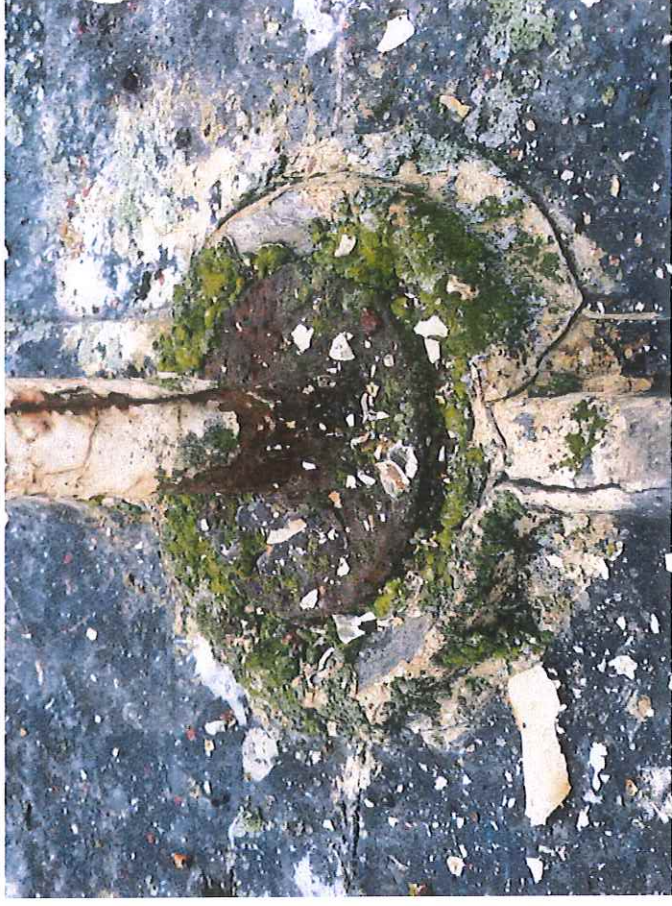
Water ingress point at fixing point of terminal. Corrosion developing at and beneath the terminal housing. New detail required.

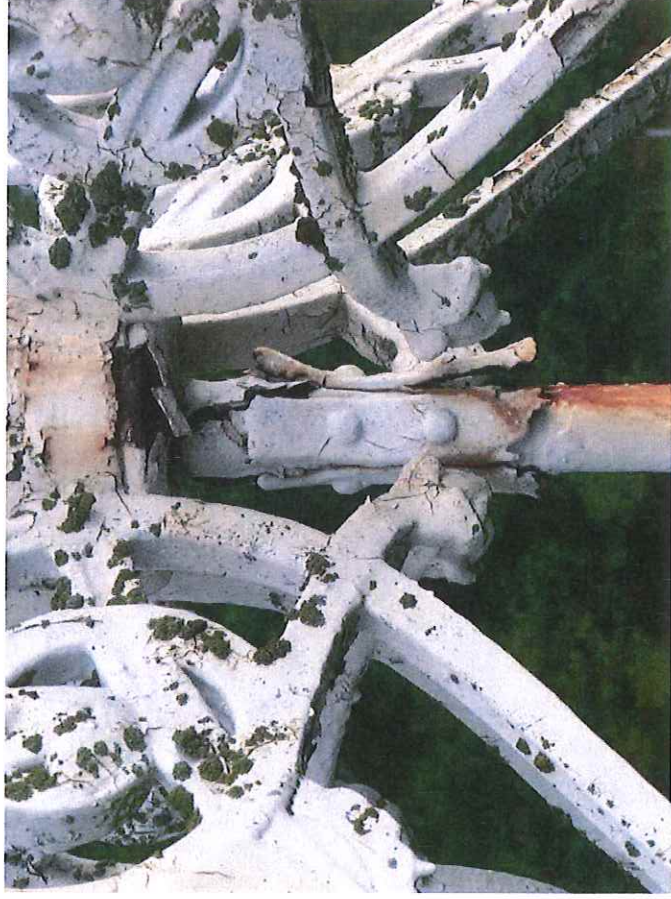
Terminal and Corona frame heavy corrosion. Area will need major work to support frame. New iron work back stays required. Corrosion at bracket and pin positions

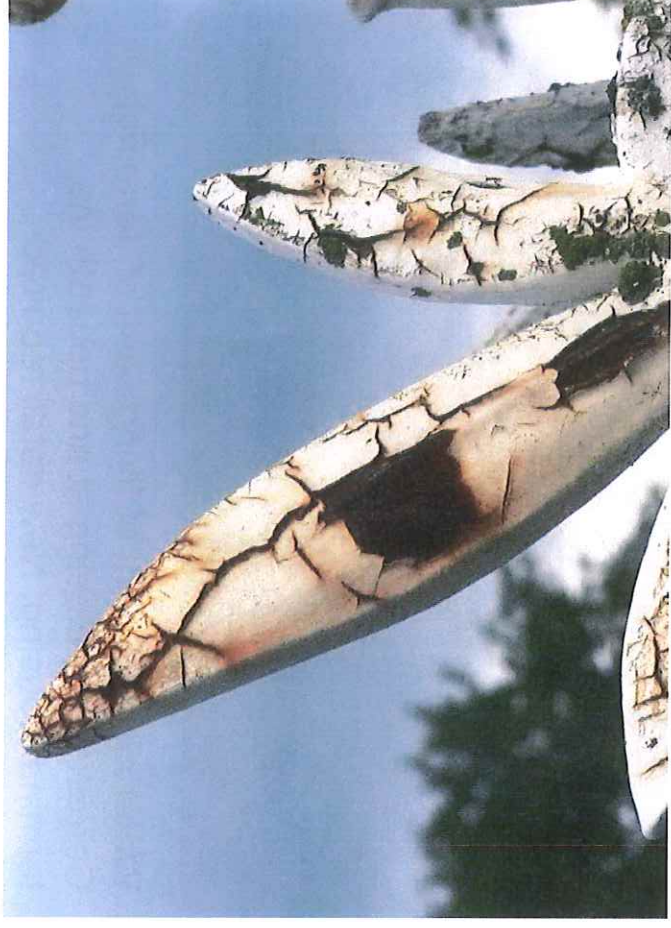
Leaf petal rib detail exposed exemplifying extent of original detail. Currently obscured by paint covering. Highly detailed ornate work.

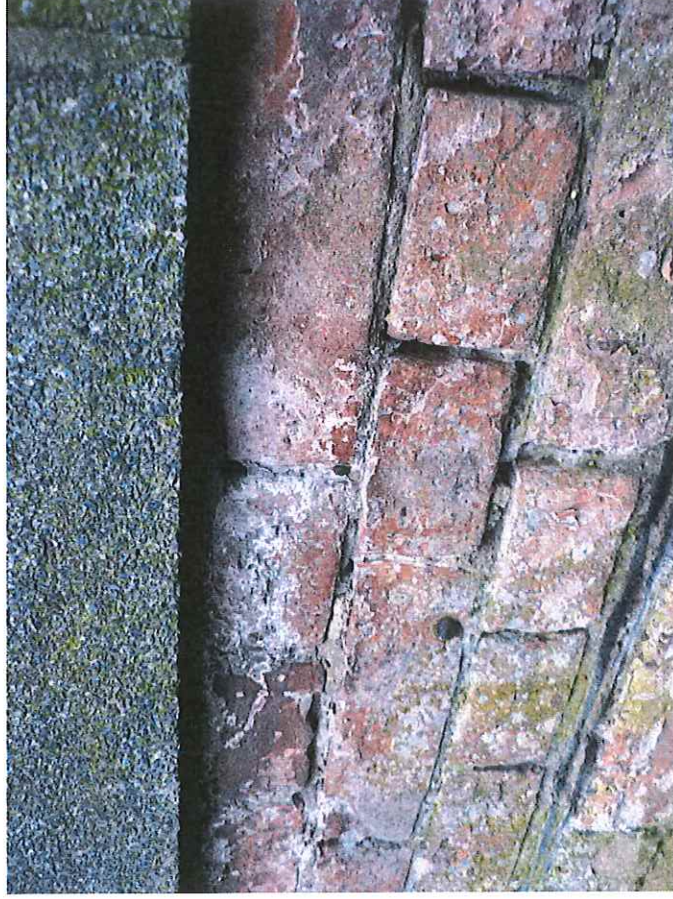
Medium soft red bricks obscured by remnants of later cement render coatings and pointing lost. Brick to be given water and aggregate abrasive clean to remove render (Vortech/Joss)

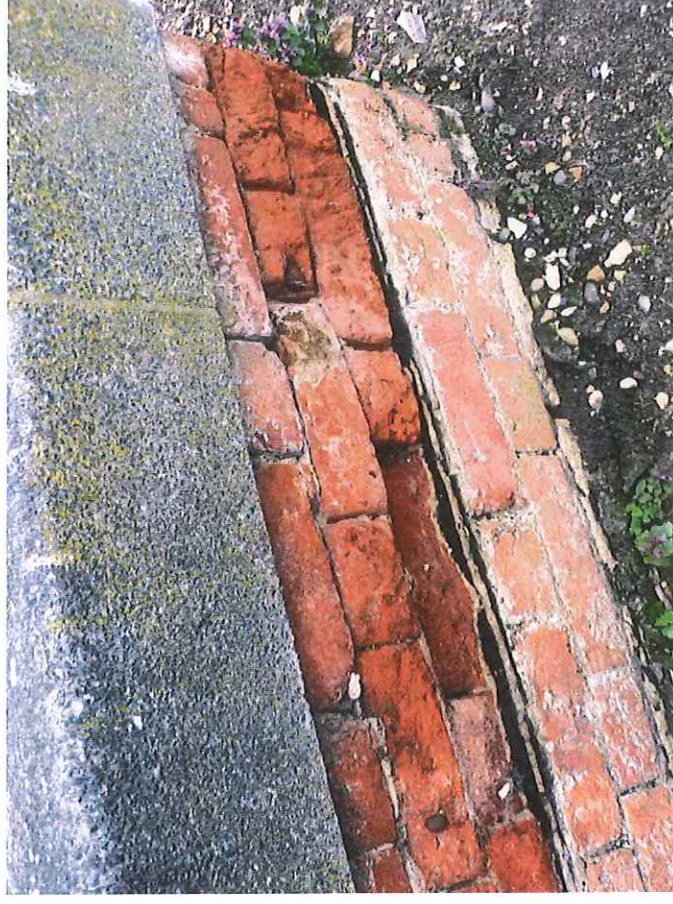
Brick indents will be required in medium soft imperial reds set in feebly hydraulic lime mortar. Note slate DPC.

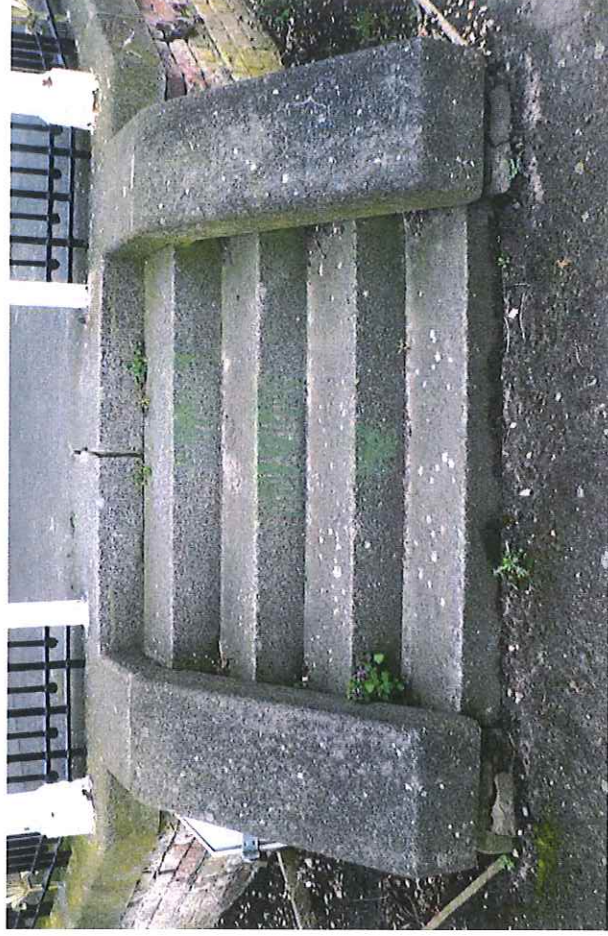
Granolithic concrete steps and landing will require deep steam cleaning and repair. Heavy duty anti slip paint can be employed as an option following mortar repairs to cracks.

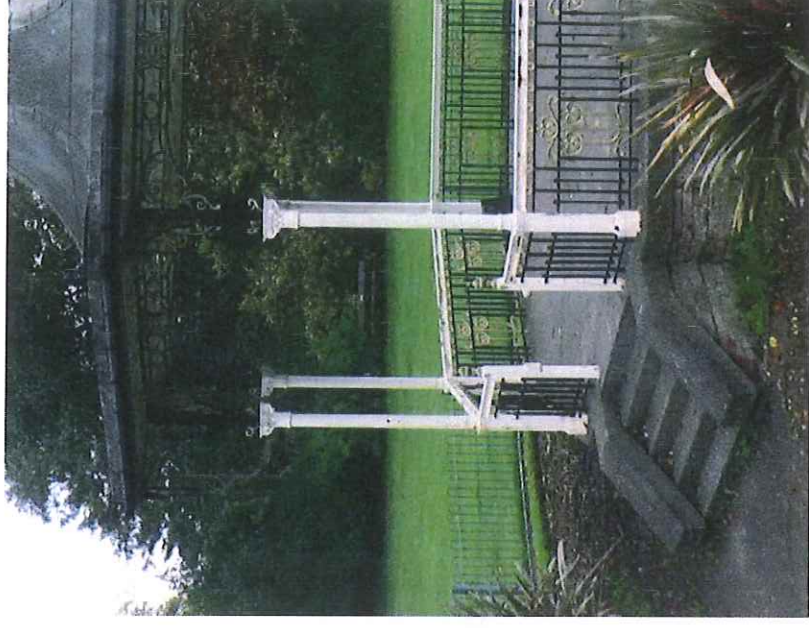
Missing gate should be included within overall budget for restoration. Detail of gate will effect overall final cost.

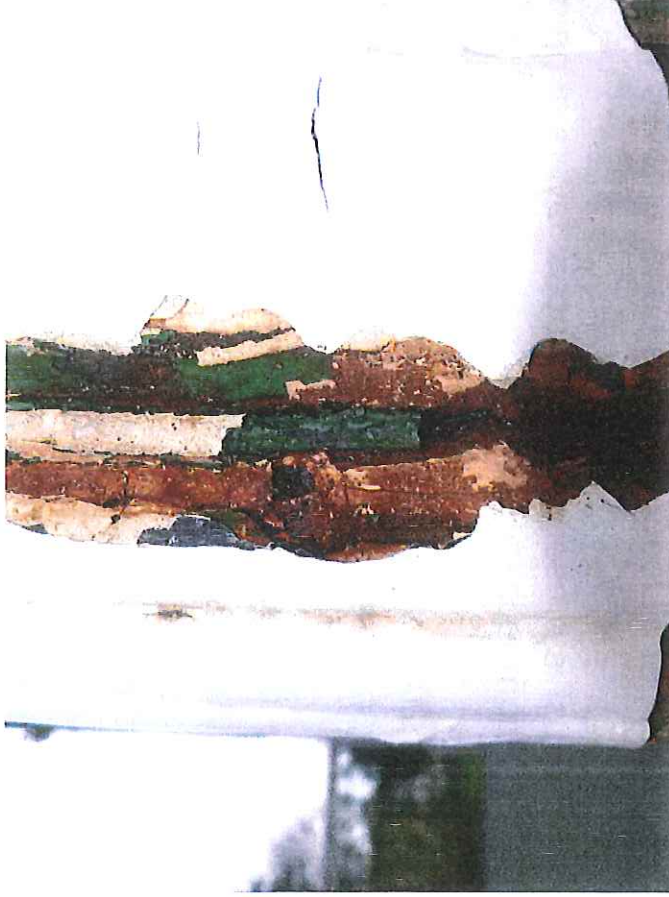
Evidence of ribbed detailing obscured. Delicacy of detail overall to bandstand aesthetically poor and illegible. Full return to detail is recommended.

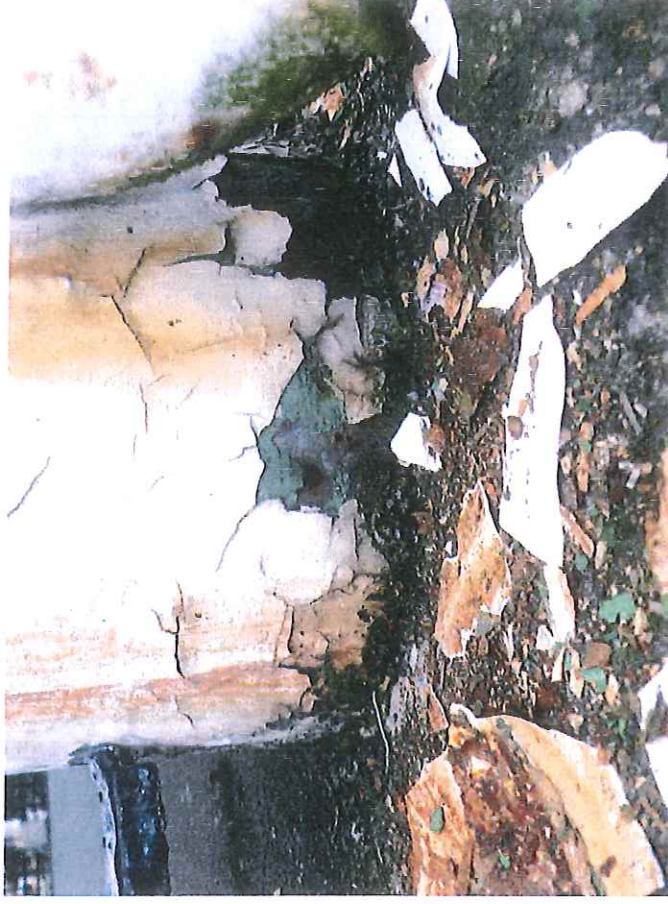
Column base and column both exhibiting green paint at the base layers
