Beckenham Public Hall Refurbishment

M&E FEASIBILITY INPUT

Issue Date: May 2020

Document Number:	BEL-BWB-00-XX-RP-ME-0001
BWB Reference:	LNS2396

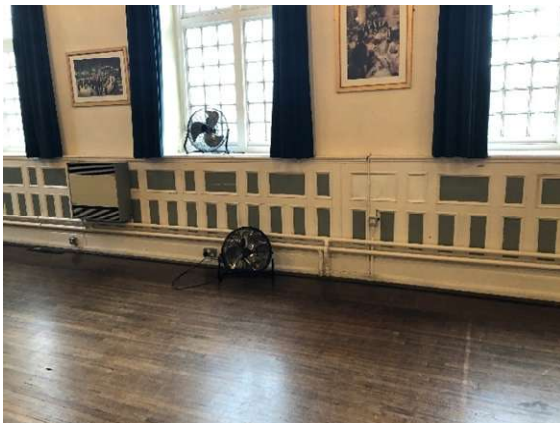
- 2.3 There are no renewable energy technologies installed to serve the building.
- 2.4 An existing gas fired boiler plant serves the Public Hall part of the building, the plant is at the end of its useful service life and requires replacement. Heating systems distribution in this part of the building is via a conventional pumped two pipe circuit which serves a combination of radiators and fan convector heaters all mounted at low level. The current community space on the first floor is heated by direct gas fired fan assisted convector heaters with the gas distribution pipework exposed at low level, this arrangement is less than ideal in a publicly accessed space and has presumably been added due to insufficient boiler plant capacity. A separate domestic scale gas fired boiler and wall mounted radiator system serves The Club part of the building and is also approaching the end of its useful service life.

Photo 3: Boiler fed fan convector + pipework

- 3.10 Heating distribution to the building is currently provided by perimeter fan convector heaters which are not suitable for a library environment due to noise pollution and the units are approaching the end of their useful life expectancy. Consequently the existing heating system shall be replaced throughout with a combination of heating provided through the mechanical ventilation system, wall mounted radiators and suspended radiant panels which could be integrated with new lighting installations. The existing exposed low level pipework distribution detracts from the aesthetic appearance of the accommodation, restricts flexibility in use of spaces and presents a risk for building users. The proposed replacement heating system will improve on the existing exposed

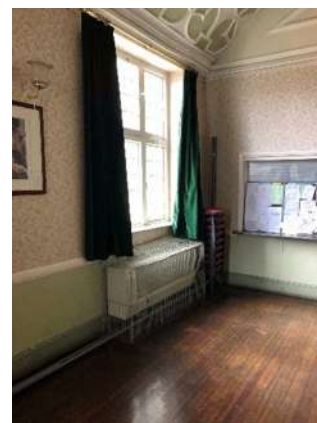
Photo 4: Convector + exposed gas pipework

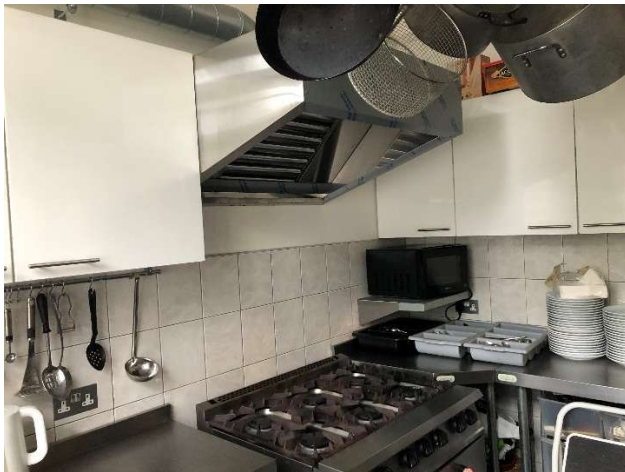
- 2.6 Ventilation to the majority of spaces in both the Public Hall and The Club is provided by manually opening windows enabling a natural ventilation approach. There is no indication from the buildings users that this approach isn't suitable in the buildings current use and any external noise and air quality pollution effects on the interior of the building through the openable window ventilation strategy haven't been raised as being significant. Local mechanical ventilation is provided to the kitchens within The Club and the community space on the first floor of the Public Hall together with the bar area in The Club and local wall mounted extract fans within toilets throughout the building. These mechanical ventilation systems appear to be in good working condition but are installed to suit the specific accommodation and equipment currently installed and therefore are unlikely to be useable following any reconfiguration of the accommodation.

Photo 5: Club kitchen vent

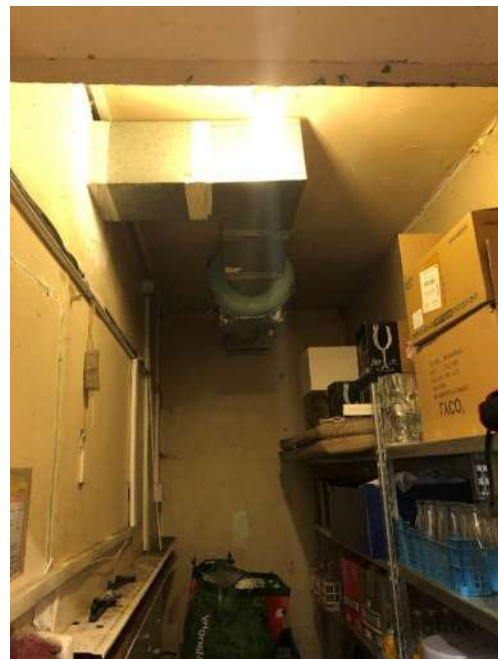
Photo 6: Club bar vent

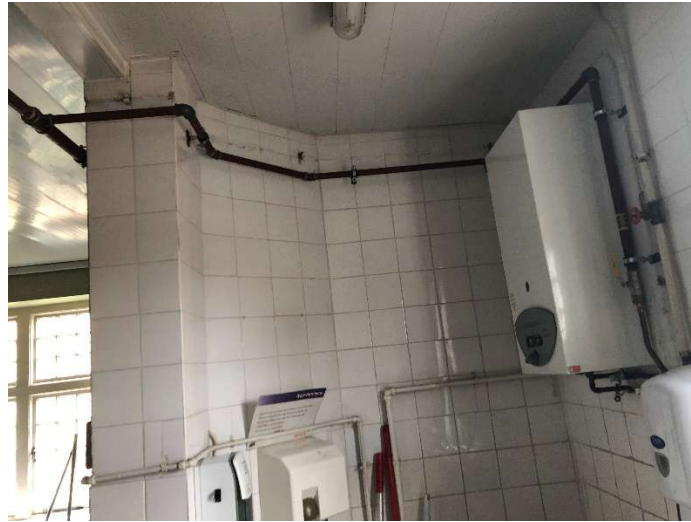
- 2.7 The building appears to be fed directly off of the mains water supply, water storage tanks and distribution equipment were not located on the initial site visit. Serving the building directly off of the mains water supply removes any risk associated with maintaining water storage tanks but does remove the ability for the building to function in the event of an interruption in the mains water supply. Domestic hot water is generated by a mix of gas fired and electrically heated point of use water heaters.

Photo 7: Community hall kitchen gas fired water heater

- 3.13 The strategy within the existing building of using point of use water heaters, either gas fired or electrically heated, for the provision of domestic hot water is appropriate to the remodelled accommodation. Consequently electric in-line point of use water heaters will be provided to wash hand facilities within toilets and gas fired water heaters provided within the main kitchen facility as the current provision.

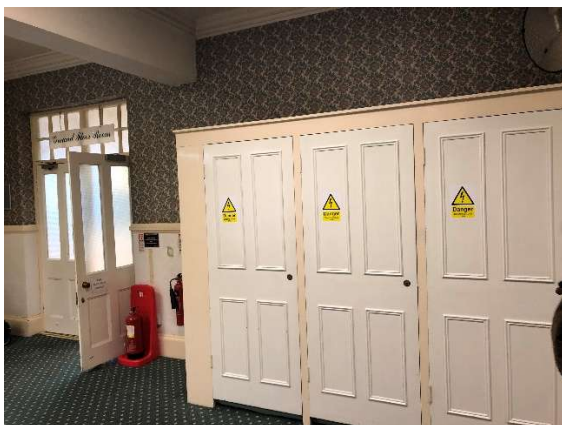
- 2.8 The mechanical building engineering services installations are provided with simplistic localised controls which do not promote energy efficiency or provide the ability for remote monitoring or set point adjustment.
- 2.9 The main electrical switchgear is thought to be housed within an enclosure located in the main entrance to the Public Hall which is obtrusive and not in an ideal location to permit maintenance operations in compliance with IEE regulations whilst the building is in use. The quality of the switchgear has not been assessed but is likely to warrant replacement to ensure the building remains maintainable and compliant with regulations.

Photo 8: Main Electrical Switchgear

- 3.14 The main electrical switchgear being located within the entrance lobby of the Public Hall is not ideal but currently operational and cost prohibitive to relocate. Consequently the main electrical switchgear will be retained in its current position and overhauled where necessary to bring it in line with current wiring regulations with metering incorporated where beneficial.
- 3.15 The proposed remodelling of the building warrants replacement of the submains distribution together with provision of new distribution boards and outgoing ways to small power and lighting circuits. The new distribution boards will be zoned to suit the use of the building and provided in suitable secure and internal locations, the quantity of distribution boards together with demarcation of zones served will be determined in the design development stage.

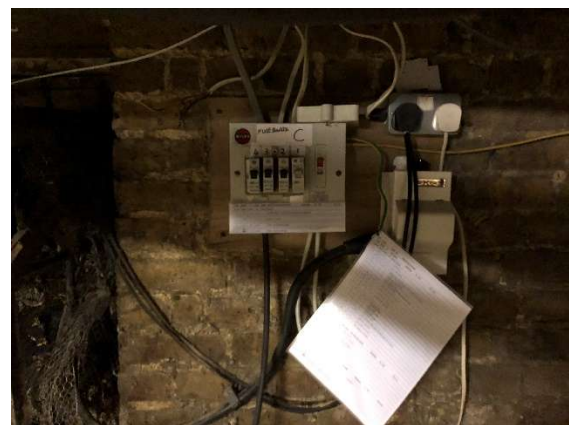
Photo 9: Electrical Distribution Equipment

- 2.10 Electrical distribution throughout the building including submain cabling, protective devices and distribution boards are in various state of repair and present a range of remaining useful service life expectancy. The existing distribution boards are arranged to suit the current zones of use in the building and are unlikely to be suited to significant refurbishment and change of use of the building. Where the existing distribution is modified it will be required to meet current IEE wiring regulations which the existing equipment will not comply with.

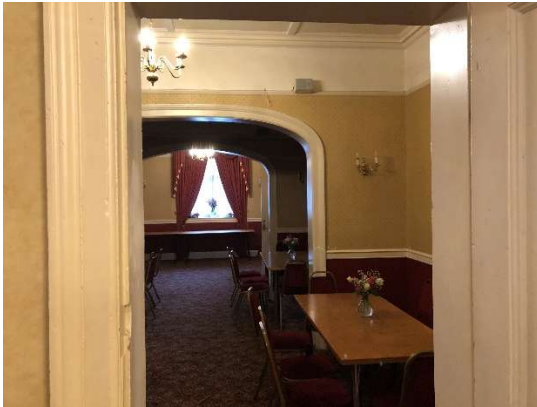
- 2.11 Lighting throughout the building is functional and aesthetically enhanced by the use of chandelier fittings with historic importance in some of the main areas. Control of the lighting fittings is by simple manual local switching and there is no evidence of daylight linking or absence detection for energy saving purposes.

Photo 10: Lighting to The Club

- 3.18 The existing general lighting systems installed throughout the building are outdated, poorly controlled and not energy efficient. Consequently the refurbishment works will be based on providing new lighting installations which shall include daylight linking enabling automatic dimming of luminaires when there is sufficient daylight distribution and the use of LED low energy fittings where possible. Where appropriate absence detection will be incorporated which shall automatically dim or turn off lighting to spaces which have not been used for a predetermined period which shall further reduce energy consumption.

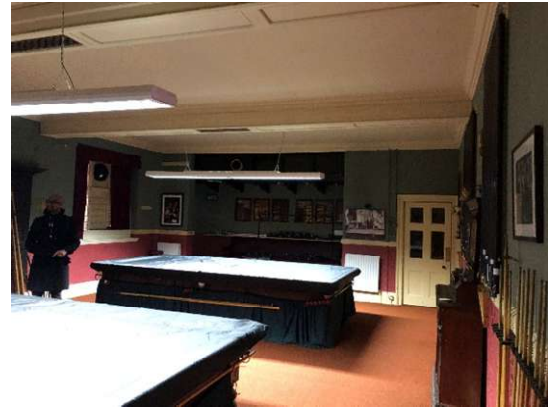
Photo 11: Club snooker room lighting

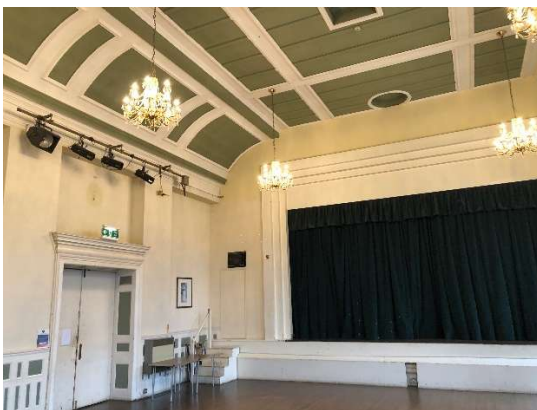
Photo 12: Chandeliers to Main Hall

- 3.19 A number of chandeliers are provided to key spaces within the building which are to be retained and refurbished, where possible to incorporate the use of low energy lamps. The chandeliers will be integrated into the general lighting scheme.

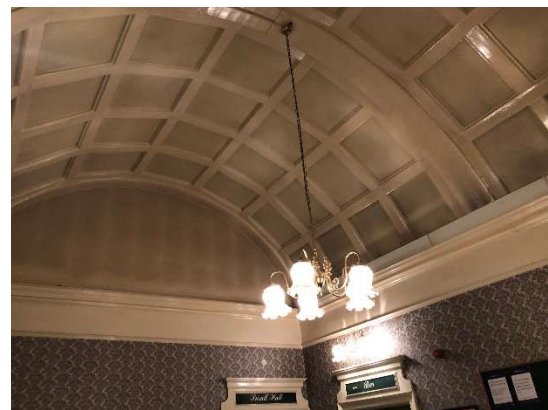
Photo 13: Central stairway lighting

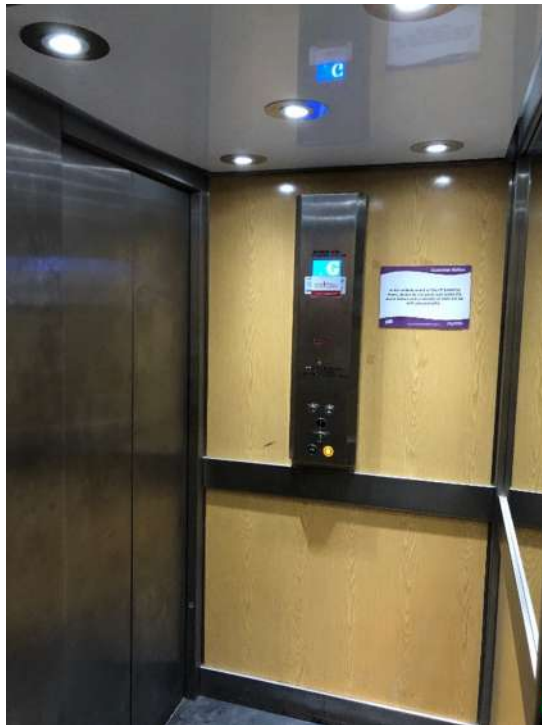
- 2.14 Vertical transportation between the ground and first floor of the Public Hall is provided by a single lift accessed off of the main entrance lobby. The lift has a change in access

door location between the two floors served to suit the accommodation on each floor and the lift car is arguably undersized for wheelchair use.

Photo 14: Lift Car

- 3.26 A new passenger lift will be provided as a direct replacement of the existing lift. The new lift will provide a larger car which is suitable for both wheelchair access and other community access requirements. The lift shaft will require enlargement to accommodate the larger lift and the new lift shall be provided as a motor-room less arrangement with the lifting gear located in the shaft and control panel provided on the first floor adjacent to the lift.
- 3.27 The specification of the size and finishes to the lift car will be determined in the design development stage.

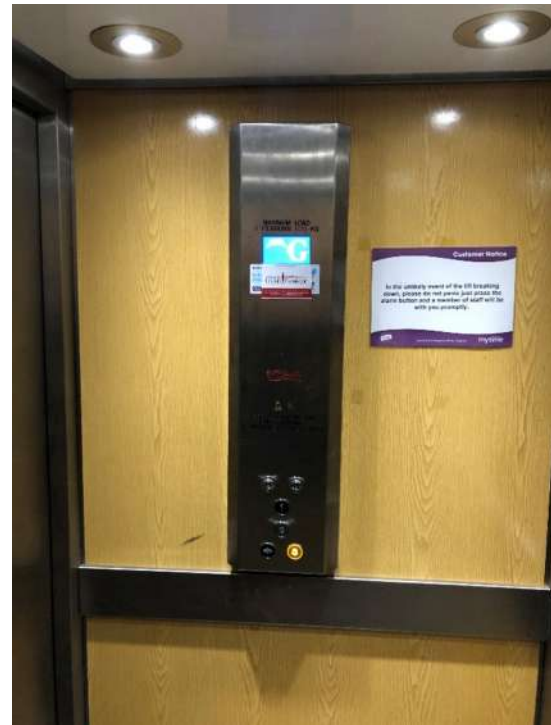
Photo 15: Lift control panel

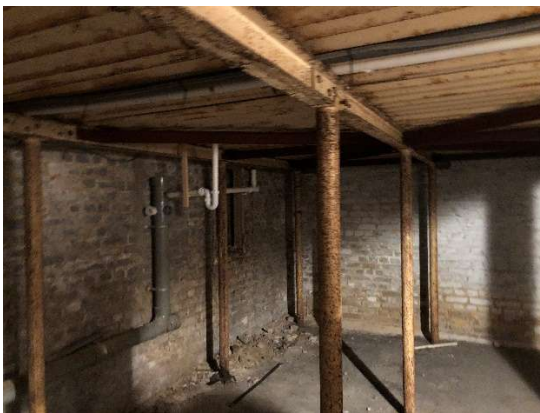
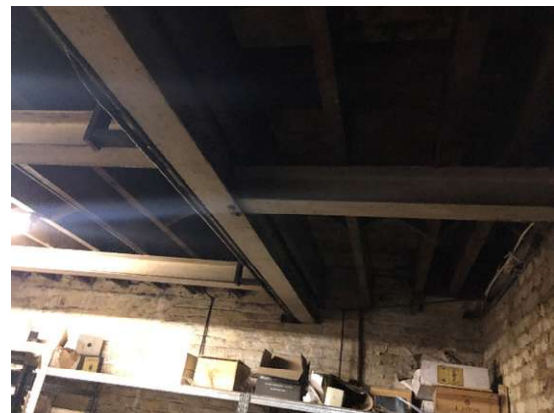
Photos 16 & 17: Basement areas needing improvement to house ventilation plant

- 3.2 The only location available for the mechanical ventilation air handling plant necessary to provide the required ventilation regime is in the basement, the affected areas of the basement will need improvement in order to house ventilation plant. It is proposed that a low level displacement ventilation approach is adopted to ensure optimum air quality within the treated spaces. Additional mechanical ventilation will be provided to kitchens, toilets etc either through refurbishment of existing installations, replacement or addition of new systems. Where spaces which are currently naturally ventilated can continue to be treated in this manner such as areas of the club mechanical ventilation will not be added.
