# PHYSICAL CONDITION SURVEY

BECKENHAM PUBLIC HALL  
4 BROMLEY LANE, BECKENHAM, BR3 5JE

FEBRUARY 2020

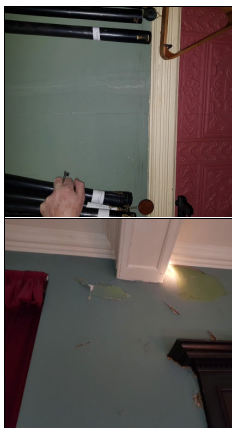
**Location:** The Club: 00 - Ground Floor - Snooker/Games Room

03 - Floor	B	£0	10	0				2030	Carpet: In reasonable condition.	No works likely to be required.
04 - Condition of Internal Walls	C	£2,500	0	1				2020	Inner wall: Cracking noted with damp at the top of the vertical through the plaster and is visible to a lesser extent to the Lounge adjacent display cupboard.	Cost allows to investigate and repair.
09 - Signs of Water Ingress	C	£25,000	0	1				2020	Signs of water ingress: Heavy damp noted to the left hand side of the fire place.	Cost allows to find the source.
