| Address | 24 Hill Close Chislehurst BR7 6HY | | |
| Application Number | 20/01232/TPO | Officer Chris Ryder | |
| Proposal | T2 Oak adjacent to 24 Hill Close - Remove. SUBJECT TO TPO 1552 (21.12.1998) | | |

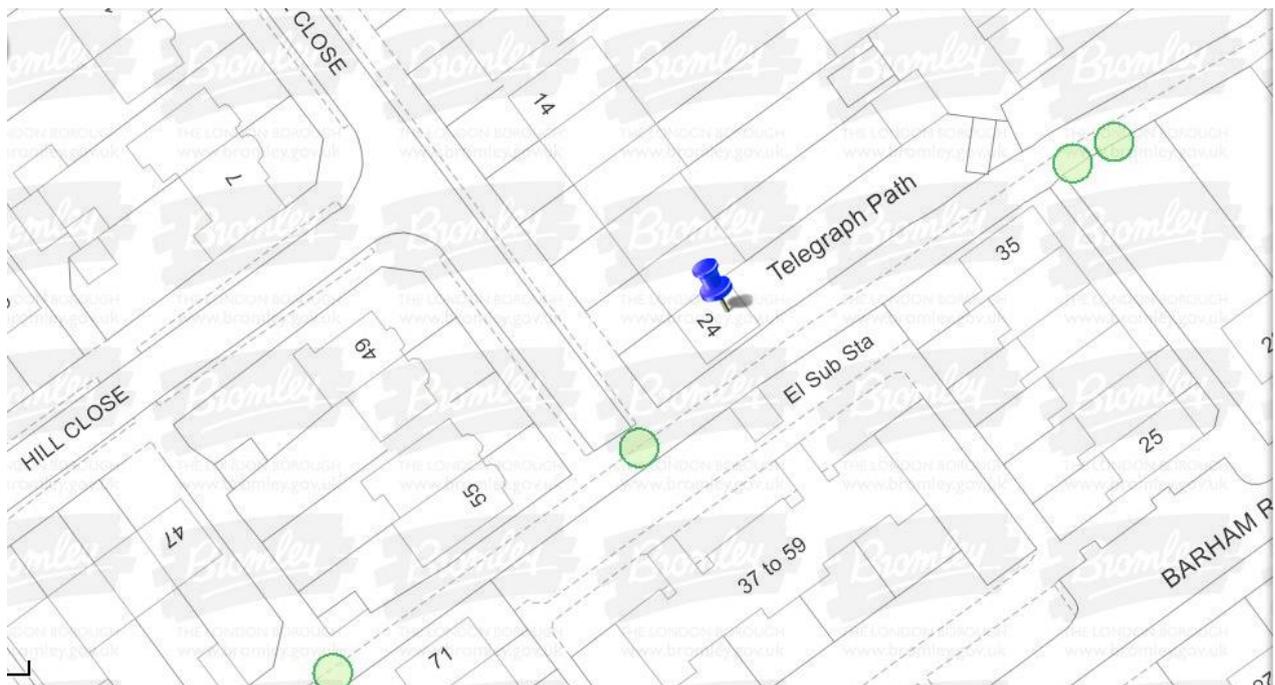
Figure 1 – 24 Hill Close

- 6.3 Damage is occurring across the front elevation of the dwelling. The Technical Report supplied in support of the application may be referred to for information on specific areas of damage. The degree of damage is category 3 (5-15mm) as listed in the Building Research Establishment; Digest 251.

- 7.5 No evidence has been presented to discount defective drainage.
- 7.6 The external damage was noted during the site visit. The cracking around the front door and referred to within the Technical Report (SU1803151) would be consistent with subsidence related damage. Category 3 cracks were measured externally around the framework of the front door.

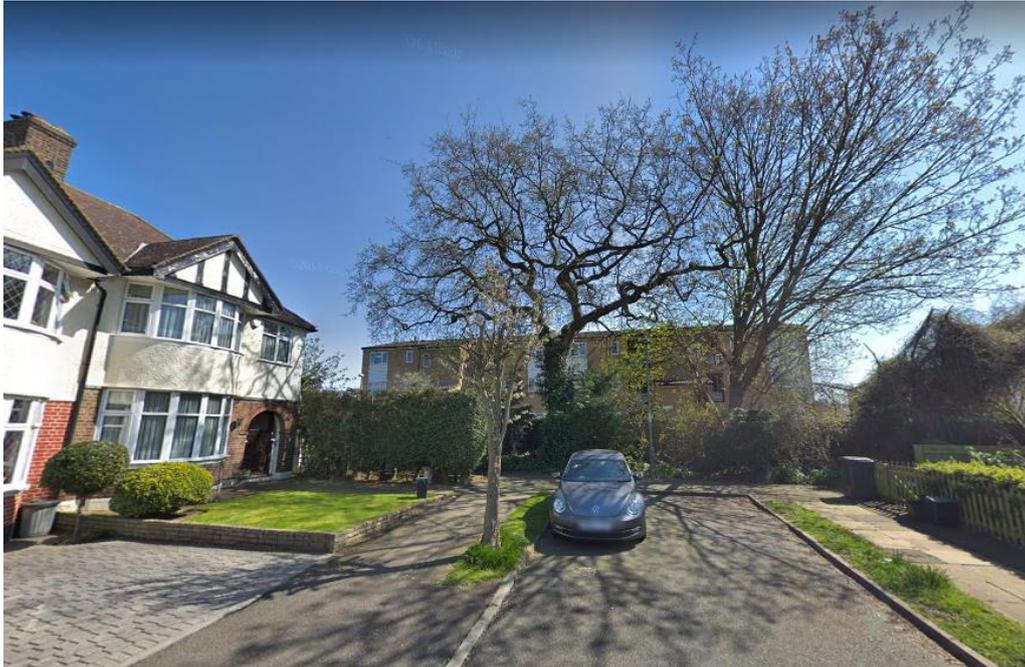
Figure 2 - Oak (T2)

- 6.2 The presence of the TPO reflects the important contribution the tree makes to the locality and the high amenity value merited. No recent management, with the exception of deadwood pruning, has been noted within the supporting tree survey or by the officer during inspection.

A site visit was carried out by the Council's Principal Tree Officer on 7th April 2019. The weather was overcast with light rain. Access internally to the property was not possible at the time of the visit. Tree survey data has been submitted as part of the application supporting documents and reference tree dimensions. No defects have been noted by the tree surveyor. The oak tree is situated 9.4m from the dwelling. The height of the tree was measured to be 15m and the zone of influence is therefore calculated to be 18.7m.

7.12 Members are recommended to refuse the application to defend the implicated trees. Further detail would be required to address the concerns raised in this report. Members should consider the value of the trees against the costs of repairs in this case. Should consent be granted, it will be necessary to apply planning conditions in mitigation to require replacement planting.

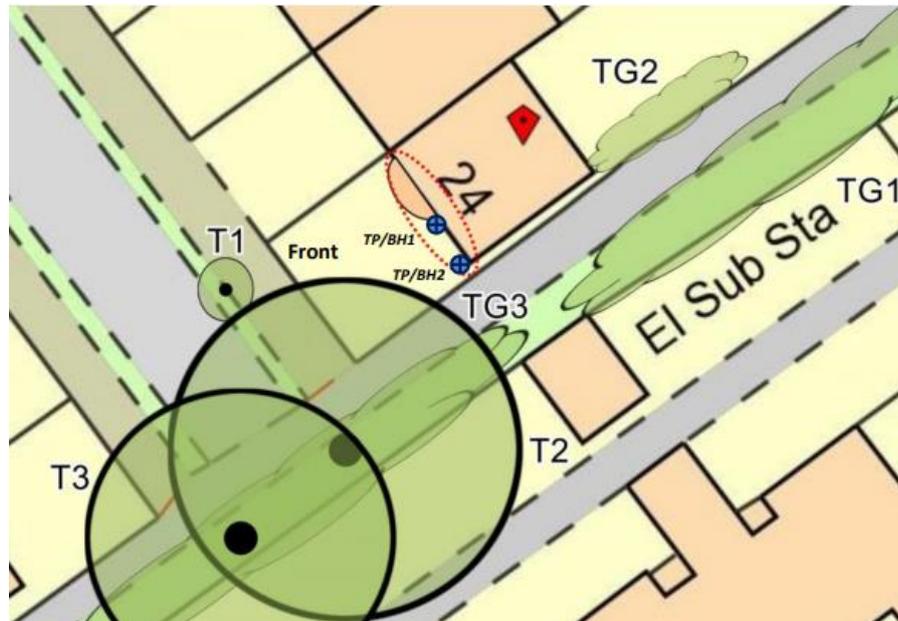
Figure 3 - Site Plan

- 6.5 Two boreholes (BH1/BH2) were excavated as part of the investigation. Foundations are revealed at depths of 550mm in BH1 and 1200mm in BH2. Root identification in BH1 reveals oak roots are beneath the foundations of the dwelling. Root identification in BH2 did not reveal live results, but were closest matched to a row of historic cypress trees and oak.

- 6.6 Level monitoring results indicate movement associated with seasonal soil moisture loss. Movement is most severe at monitoring stations 4 - 6 positioned along the front elevation. The period of monitoring is 12 months from September 2018 to September 2019.
