<b>Committee Date</b>	26 <sup>th</sup> November 2020	
<b>Address</b>	22 Hill Close Chislehurst BR7 6HY	
<b>Application Number</b>	20/01817/TPO	<b>Officer</b> Chris Ryder
<b>Ward</b>	Chislehurst	
<b>Proposal</b>	T1 Oak - Fell. SUBJECT TO TPO 1552 (21.12.1998)	
<b>Applicant</b> Ms Underwood Subsidence Management Services First Floor Gateway House 4 Penman Way Grove Business Park Leicester LE19 1SY	<b>Agent</b> Innovation Group Environmental Services 4 Linnet Court Cawledge Business Park Alnwick NE66 2GD	
<b>Reason for referral to committee</b>	Subsidence case. Returning deferral.	<b>Councillor call in</b> No
<b>RECOMMENDATION</b>	Refusal

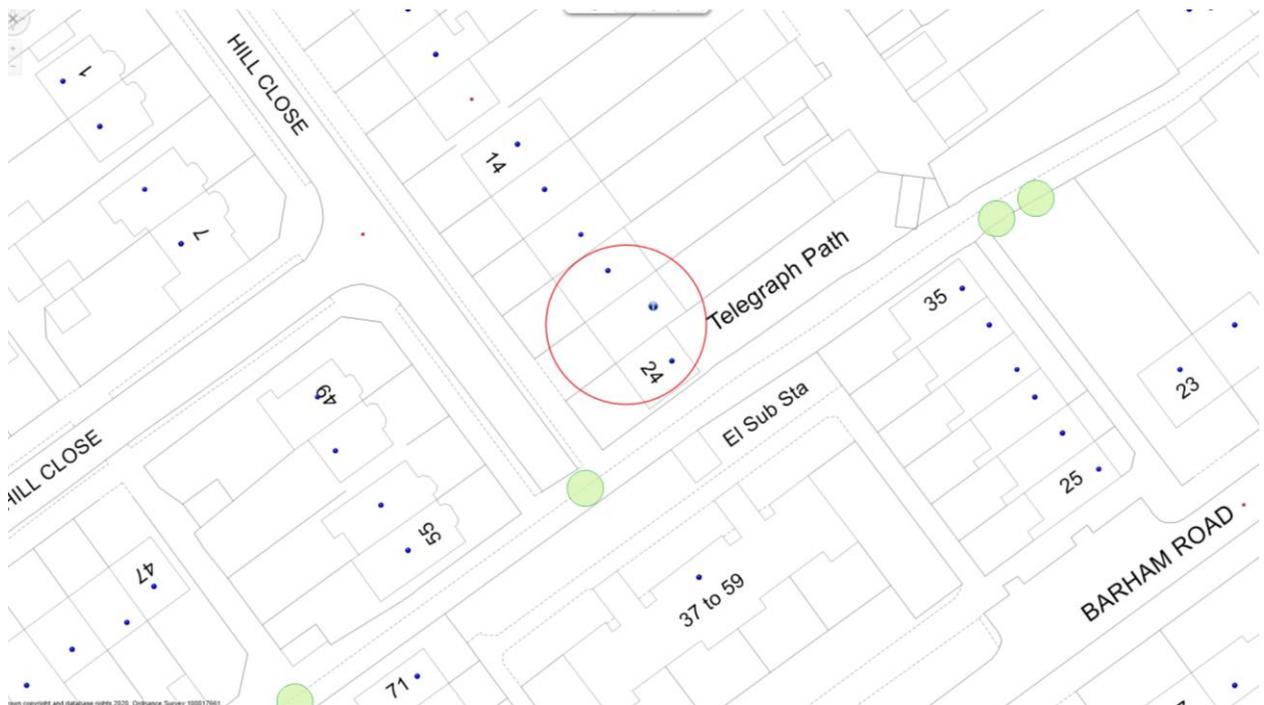
Figure 1 – 22 Hill Close

6.3 Damage is occurring across the front elevation of the dwelling. The Technical Report supplied in support of the application may be referred to for information on specific areas of damage. The degree of damage is category 2 (1-5mm) as listed in the Building Research Establishment; Digest 251.

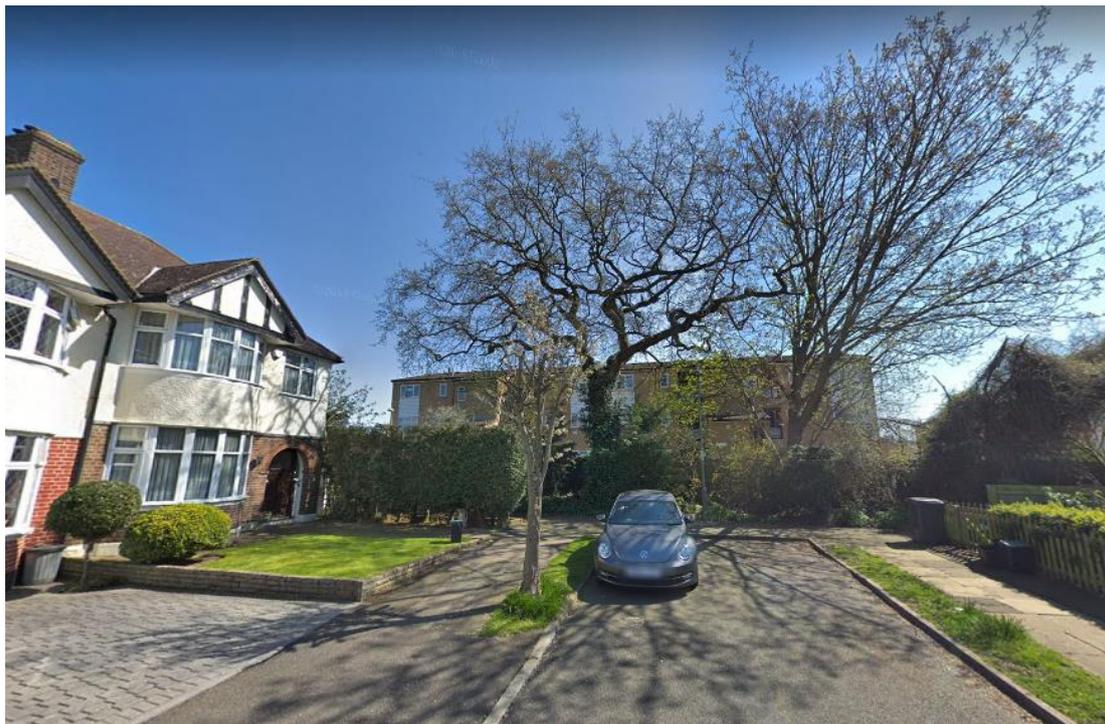
**Figure 2 - Oak (T2)**

6.5 A site visit was carried out by the Council's Principal Tree Officer on 7th April 2019. The weather was overcast with light rain. Tree survey data has been submitted as part of the application supporting documents and reference tree dimensions. No defects have been noted by the tree surveyor. The oak tree is situated 15.4m from the dwelling. The height of the tree was measured to be 15m and the zone of influence is therefore calculated to be 18.7m.

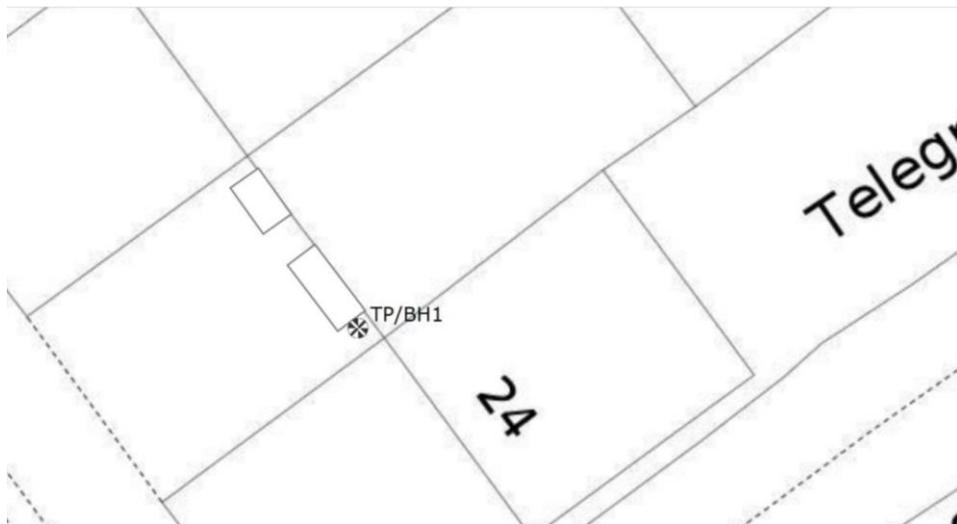
**Figure 3 - Site Plan**

6.6 One borehole (BH1) was excavated as part of the investigation. Foundations are revealed at a depth of 700mm. Root identification in BH1 reveals oak roots are beneath the foundations of the dwelling.
