Committee Date	11 th November 2021		
Address	13 Tylney Road, Bromley, BR1 2RJ		
Application Number	21/01958/TPO	Officer Chris Ryder	
Ward	Bickley		
Proposal	T2 Oak on land to rear of 13-35 Tylney Road - Remove. SUBJECT TO TPO 907 (21.12.1993)		
Applicant Crawford and Company Cartwright House Nottingham UK	Agent MWA Arboriculture Ltd Bloxham Mill Business Centre Barford Road Bloxham Banbury OX15 4FF United Kingdom		
Reason for referral to committee	Subsidence related financial risk	Councillor call in	
RECOMMENDATION	Refusal

T2 Oak on land to rear of 13-35 Tylney Road - Remove.

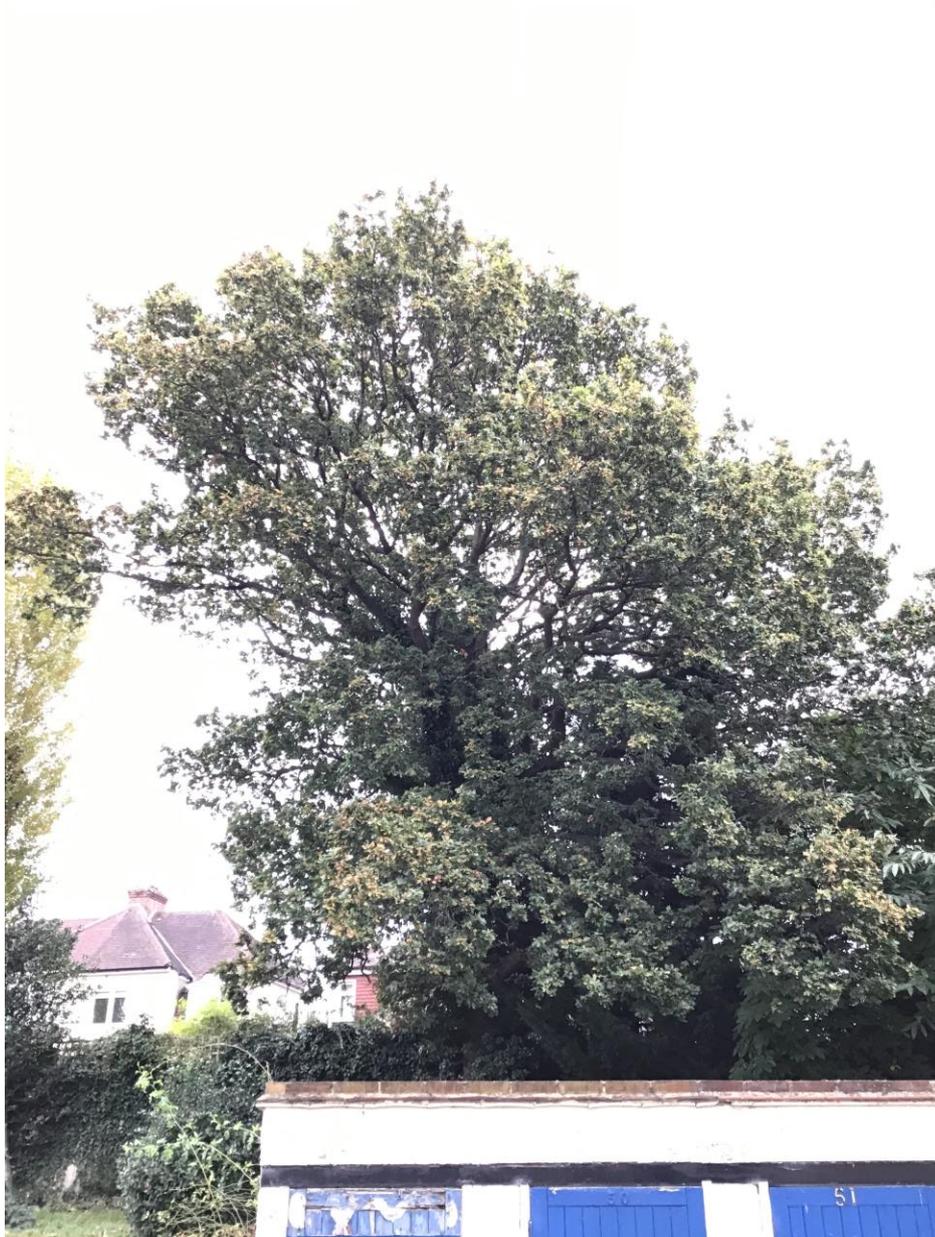
Figure 1 - Oak (T2)

- 6.2 Officers made a site visit on 14th October 2021. The subject tree is confirmed to be within the zone of influence. The tree has been measured at 15m from the rear elevation of the policy holder's dwelling. Tree survey data has been submitted as part of the application supporting documents and reference tree dimensions. The tree appears to be of normal vitality with no recent management evident. The tree is confirmed older than the surrounding dwellings.

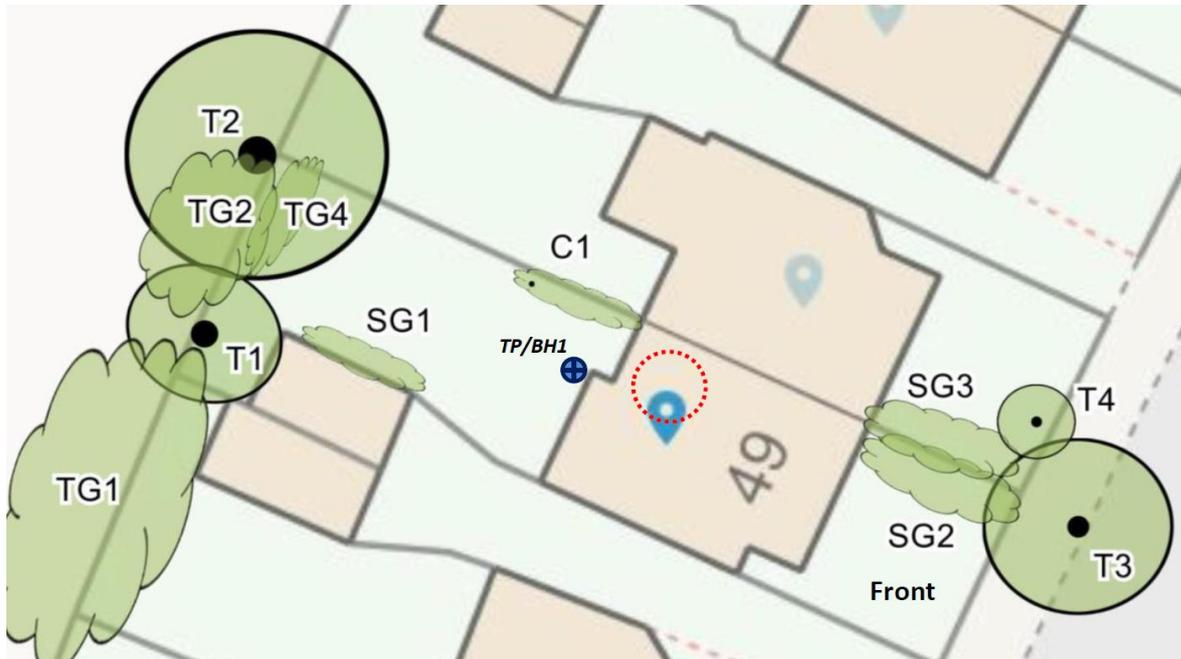
Figure 3 - Site Plan

- 6.5 One borehole (TP1) was excavated as part of the investigation. This revealed foundations to depths of 950mm. Root identification in the borehole indicate oak roots are present.
