Beckenham Public Hall Refurbishment

M&E FEASIBILITY INPUT

Issue Date: May 2020

Document Number:	BEL-BWB-00-XX-RP-ME-0001
BWB Reference:	LNS2396

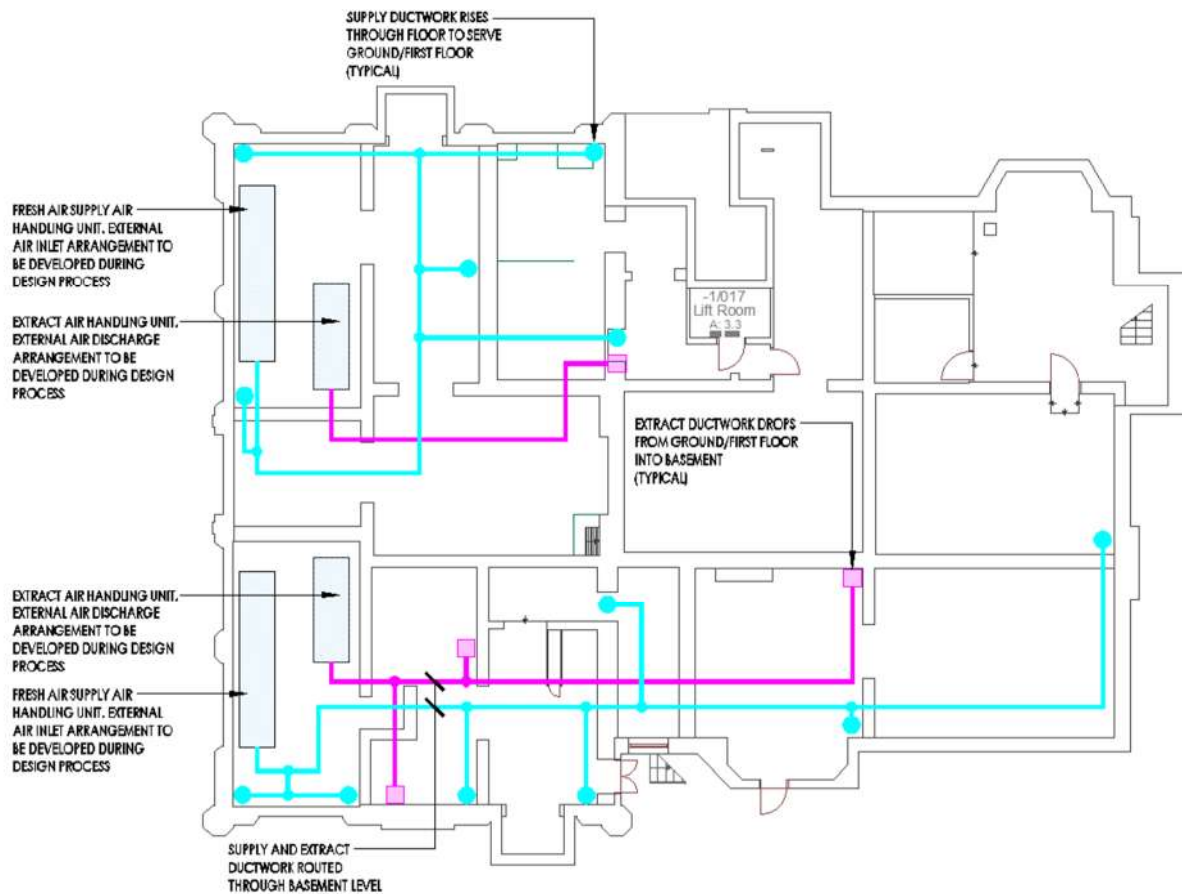
Figure 1: Basement ventilation plant and ductwork routing proposal

- 3.3 The sketch below indicates the areas of the basement where mechanical ventilation plant is proposed to be placed together with the routing of supply and extract ductwork required to serve the ground and first floors. The arrangement of bringing fresh air into the air handling plant from outside of the building and discharging vitiated air out of the building requires further development.

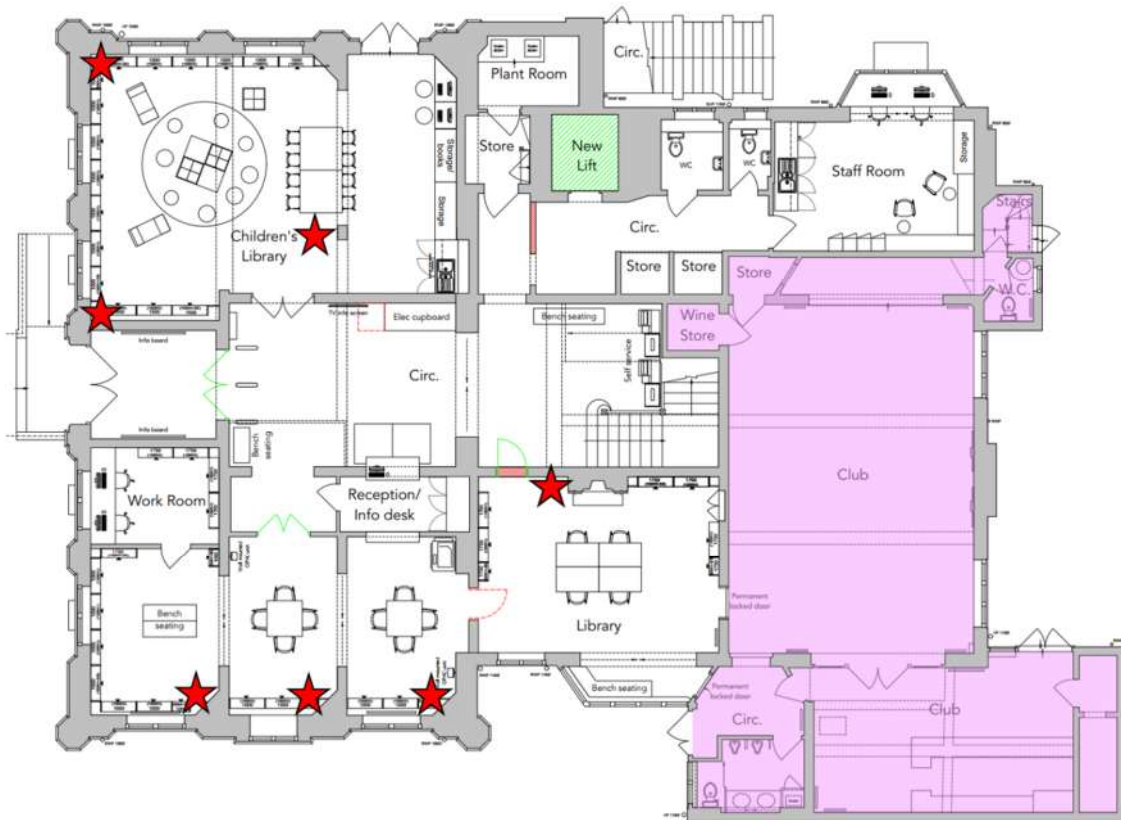
Figure 4: Ground Floor Option 4 Layout – Proposed Displacement Ventilation Outlet Locations

3.6 The sketches below propose locations for the low level displacement ventilation terminals using Option 4 of the architectural layouts, terminal locations are marked using a red star. The displacement ventilation strategy is particularly suited to the type of library accommodation planned for the Public Hall building as it delivers fresh air directly to the occupants producing an improved internal air quality, does not rely on routing ductwork at high level in the main spaces which would have a visual effect and supports low internal noise levels. Vitiated air would be removed from the spaces at high level using vertically mounted grilles preferably built into furniture or positioned within walls with ductwork connections back to the basement air handling plant. The majority of the space heating requirements would be delivered by the displacement ventilation system except for peak heating periods when the ventilation plant would be assisted by suspended radiant panel heaters fed from the boiler plant. Energy efficiency would be incorporated within the mechanical ventilation systems by the use of heat recovery devices and by varying the volume of air delivered to each space to suit internal air quality and temperature.

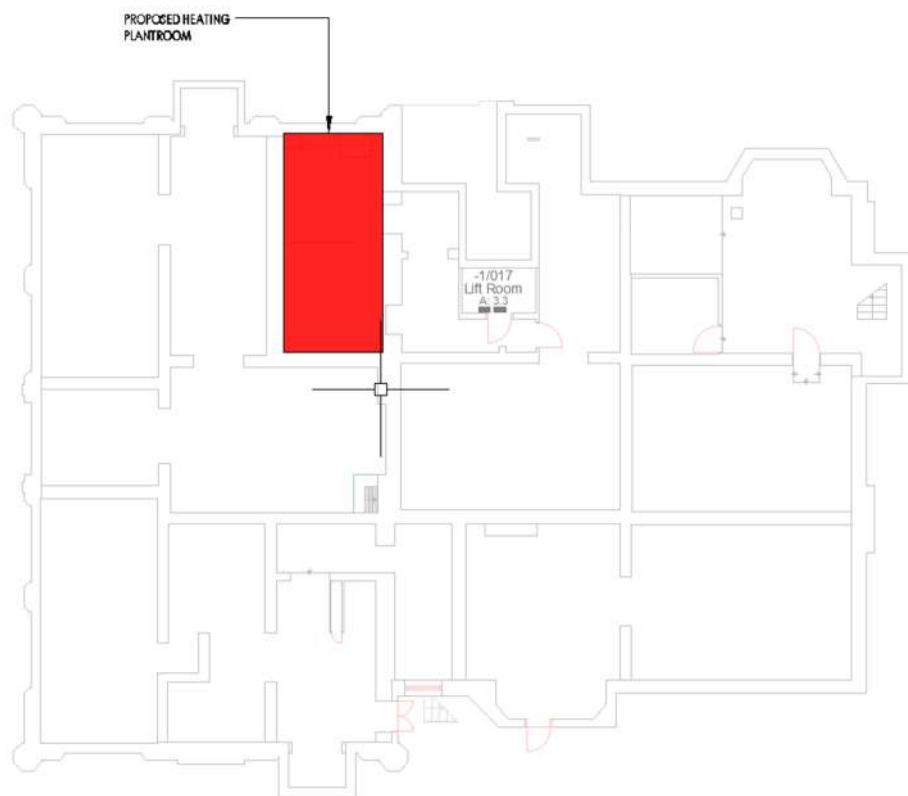
Figure 6: Proposed basement heating plantroom relocation

- 3.8 The existing gas fired boiler plant serves the public hall part of the building, the plant is at the end of its useful service life and requires replacement. A condition survey provided by the client advises that the distribution pumps and ancillary equipment within the heating system are operational.
- 3.9 The addition of mechanical ventilation to the public library areas increases the heating load to the building which combined with the need to replace the current boiler plant imposes the need to relocate the boiler plant to a larger plantroom which is proposed to be located in the basement. The new and enlarged heating plant is likely to require a replacement to the gas supply to the building and provision of combustion air together with a route for boiler flues preferably to roof level require further investigation within the design development stage.
