# PHYSICAL CONDITION SURVEY

BECKENHAM PUBLIC HALL  
4 BROMLEY LANE, BECKENHAM, BR3 5JE

FEBRUARY 2020

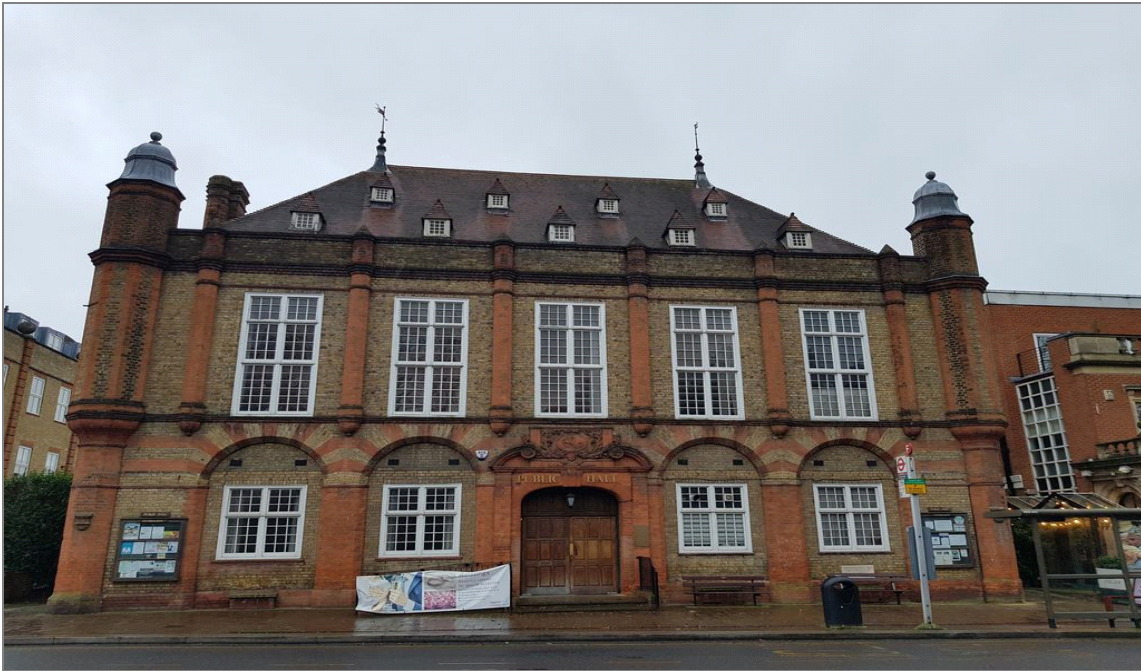
### 001 Beckenham Public Hall Block 001 - Main Building

**Type of Construction:** This is a two storey brick framed, traditional Town Hall constructed in 1883 with a decorative brick façade and single storey section to the rear right hand side which forms the entrance to The Club that encompasses the majority of the Ground Floor and Basement. The roofs are a combination of pitched clay and slate roofs along with flat original asphalt roofs.
