Committee Date	26 th November 2020	
Address	9 Almond Close Bromley BR2 8DS	
Application Number	20/00015/TPO	Officer Chris Ryder
Ward	Bromley Common & Keston	
Proposal	T1 Oak - Fell. T2 Oak at 11 Almond Close - Fell.	
Applicant Mr Flemons Subsidence Management Services First Floor Gateway House 4 Penman Way Grove business Park Leicester	Agent Mrs Kim Fisher Environmental Services Unit 4 Linnet Court Cawledge Buisness Park Alnwick NE66 2GD United Kingdom	
Reason for referral to committee	Returning application following deferral on 9 th July 2020	Councillor call in
RECOMMENDATION	Refusal

1. This application has been made in respect of both T1 and T2 in connection with a subsidence investigation. The trees are positioned at the back of the rear garden, close to the boundary with the neighbouring public footpath. The felling of the trees is proposed to achieve building stabilisation in accordance with the professional recommendations.

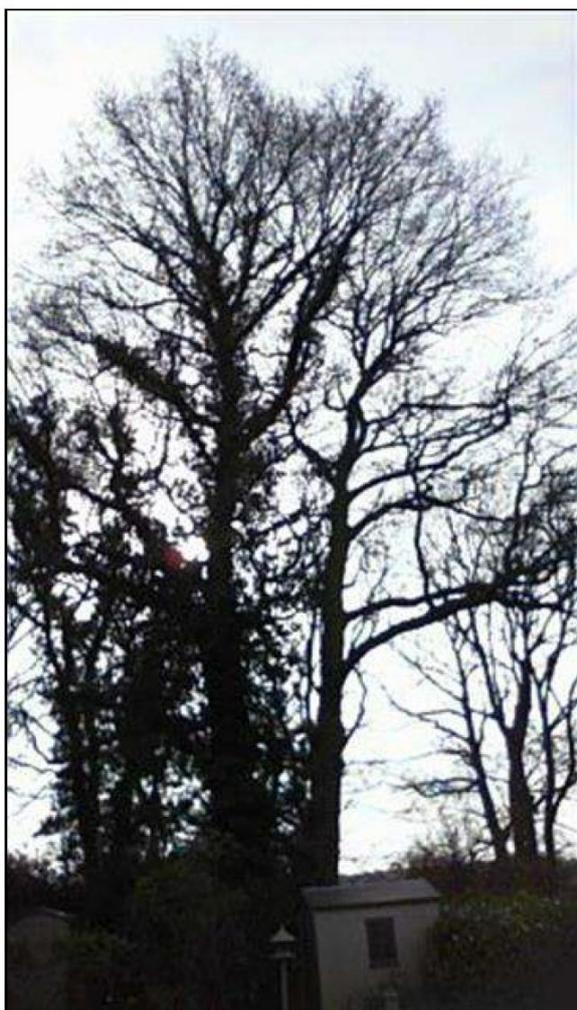
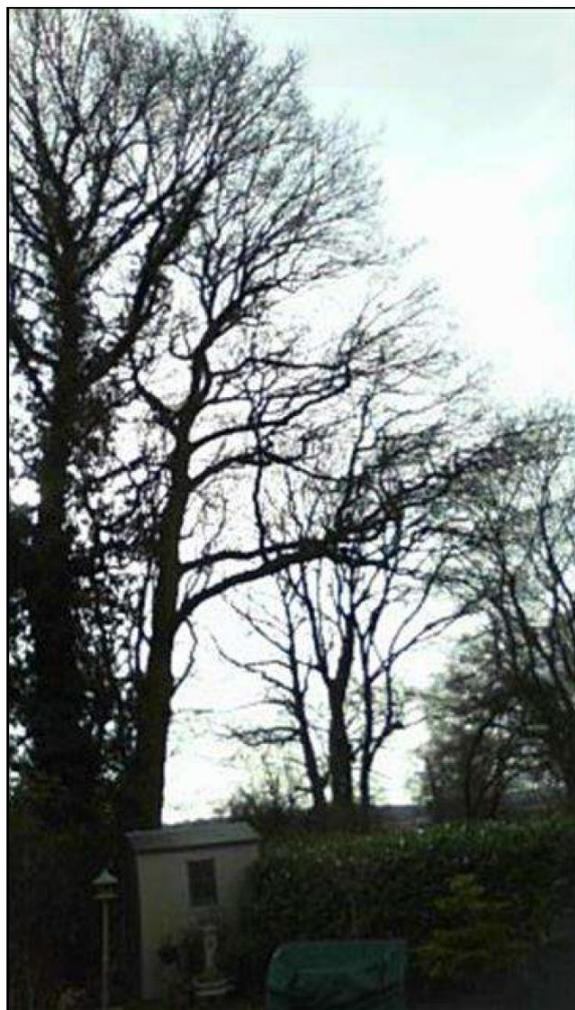
Figure 1 - Oak (T1/T2)

T1 - Oak

T2 - Oak

2. The application site is comprised of a semi-detached dwelling located on the east side of Almond Close. Oak tree (T1) is situated within the application site and oak tree (T2) is situated within the rear garden of 11 Almond Close. Both properties back onto a public footpath to the south and agricultural fields thereafter.
