Committee Date	27 th May 2021	
Address	45 Broadoaks Way Bromley BR2 0UA	
Application Number	21/00125/TPO	Officer Chris Ryder
Ward	Shortlands	
Proposal	T1 Oak - Remove	
Applicant Gowher Shah Crawford and Company Cartwright House Nottingham	Agent Vicki Harrision MWA Arboriculture Bloxham Mill Business Centre Barford Road Bloxham Banbury OX15 4FF	
Reason for referral to committee	Subsidence related financial risk	Councillor call in
RECOMMENDATION	Refusal

1. This application has been made in respect of oak tree (T1) in connection with a subsidence investigation at 8 Penshurst Green, Bromley, BR2 9DG. The tree is positioned in the rear garden of 45 Broadoaks Way. The felling of the tree is proposed to achieve building stabilisation in accordance with the professional recommendations.

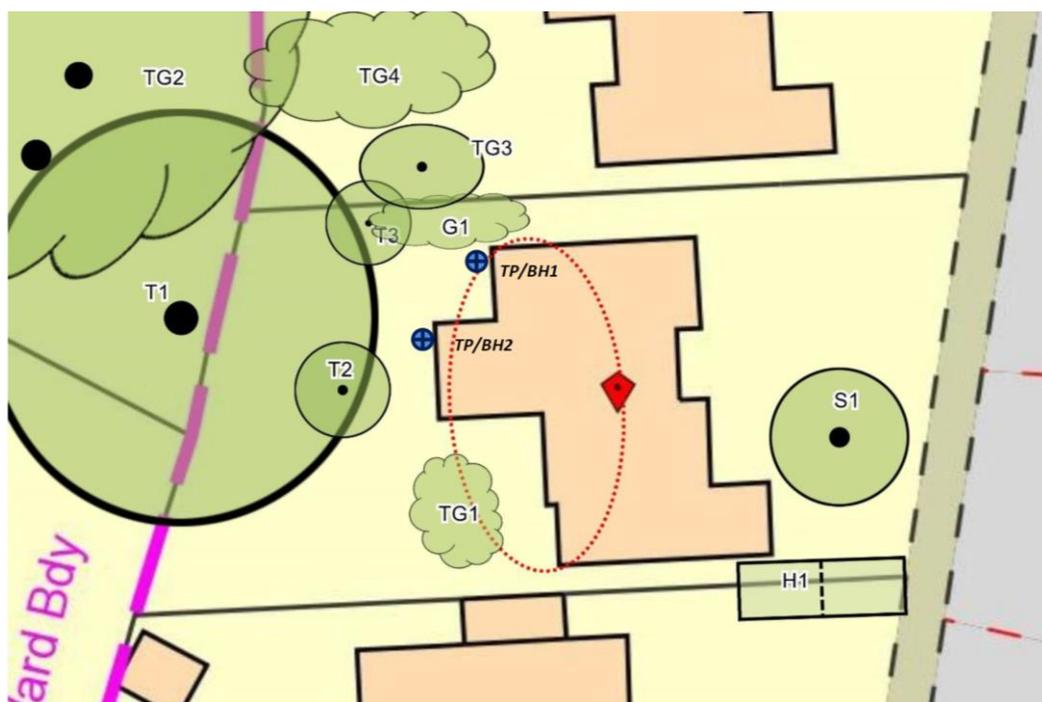
Figure 3 - Site Plan

6.5 Two boreholes (TP1/TP2) were excavated as part of the investigation. This revealed foundations to depths of 850mm in TP1 adjacent to the single storey rear extension and 400mm in TP2 adjacent to the conservatory. Past underpinning appears to have been installed under the conservatory. Root identification in the borehole reveals oak roots are beneath the foundations of the dwelling. Underpinning does not appear to have been extended beneath the rear extension.

6.6 Level monitoring results indicate movement associated with seasonal soil moisture loss. Movement is most severe at monitoring stations 6-8 positioned along the rear elevation of the conservatory.
