<b>Committee Date</b>	22 <sup>nd</sup> July 2021		
<b>Address</b>	Sundridge Park Golf Club, Garden Road, Bromley, BR1 3NE		
<b>Application Number</b>	21/01089/TPO	<b>Officer</b> Chris Ryder	
<b>Ward</b>	Plaistow & Sundridge		
<b>Proposal</b>	Fell and treat (deciduous) x3 Oak trees (T3, T4 and T5) at Sundridge Park Golf Club SUBJECT TO TPO 690 (26.10.1990)		
<b>Applicant</b> Mr C Thomas PRI Insurance 2 The Courtyards Phoenix Square Severalls Park Colchester CO4 9PE	<b>Agent</b>		
<b>Reason for referral to committee</b>	Subsidence related financial risk	<b>Councillor call in</b>	
<b>RECOMMENDATION</b>	Refusal

1. This application has been made in respect of oak trees (T3-T5) located in the grounds of Sundridge Park Golf Course, in connection with a subsidence investigation at 105 New Street Hill, Bromley, BR1 5BA. The felling of the trees is proposed to achieve building stabilisation in accordance with the professional recommendations.

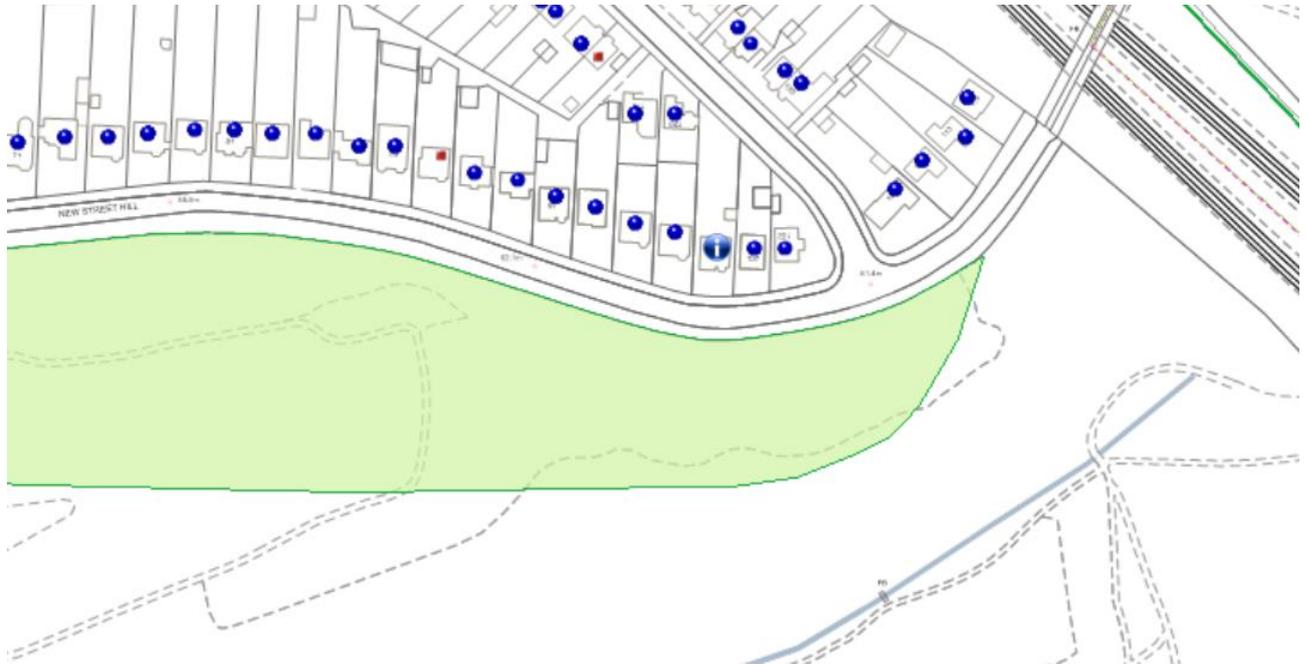
*Figure 2 - Site Location*

2. The application site consists of a golf course located to the north of Bromley, bordering New Street Hill to the West. The insured property subject of this subsidence claim comprises a detached two storey dwelling that dates back to the 1930s. The property is located on a rising slope from the road. The front has been landscaped to incorporate a drive way and associated hard surfacing. There are no significant trees within the property and no restrictions in terms of protected trees.

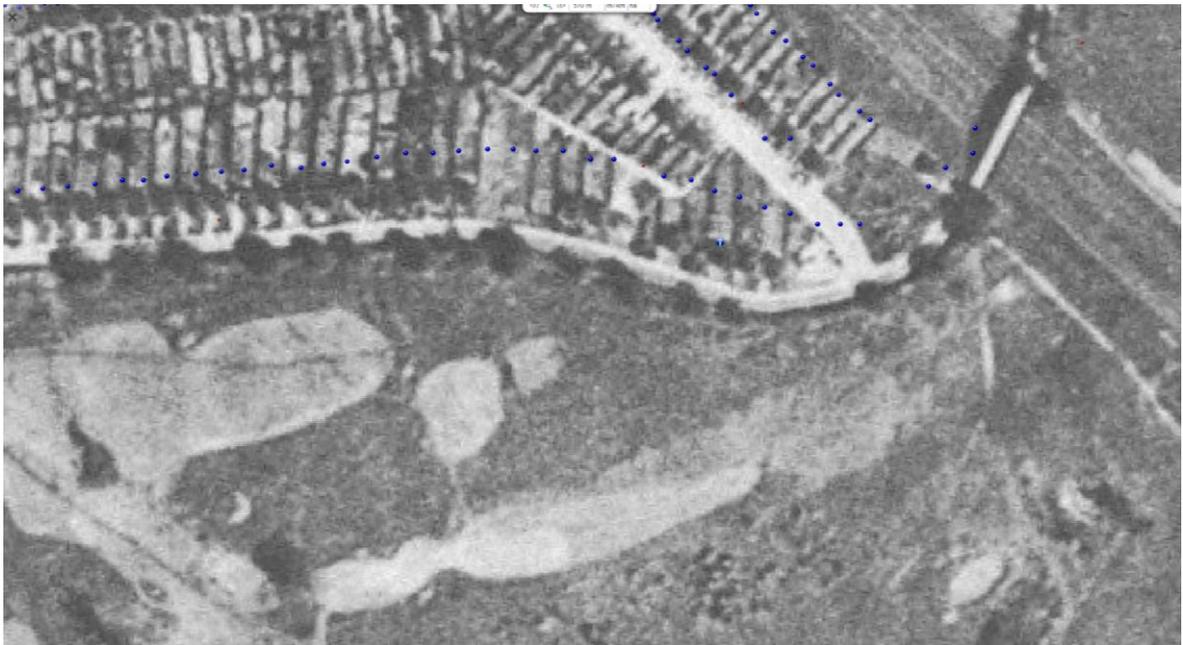
*Figure 3 – Aerial photo (1940)*

- 6.2 The subject oak trees are approximately 20m from the front of the dwelling. Highly visible in the street scene, the trees are considered to be of high amenity value, cohesive with other trees in the wooded belt. The trees are also considered to be of ecological importance. One of the trees appears to have been felled by the golf course on safety grounds.
- 6.3 The subject trees are confirmed to be within the zone of influence. The trees have been measured between 20.8m from the front projection of the policy holder's dwelling. Tree survey data has been submitted as part of the application supporting documents and reference tree dimensions. The trees appear to be of normal vitality with no recent management evident. The trees are estimated older than the surrounding dwellings.

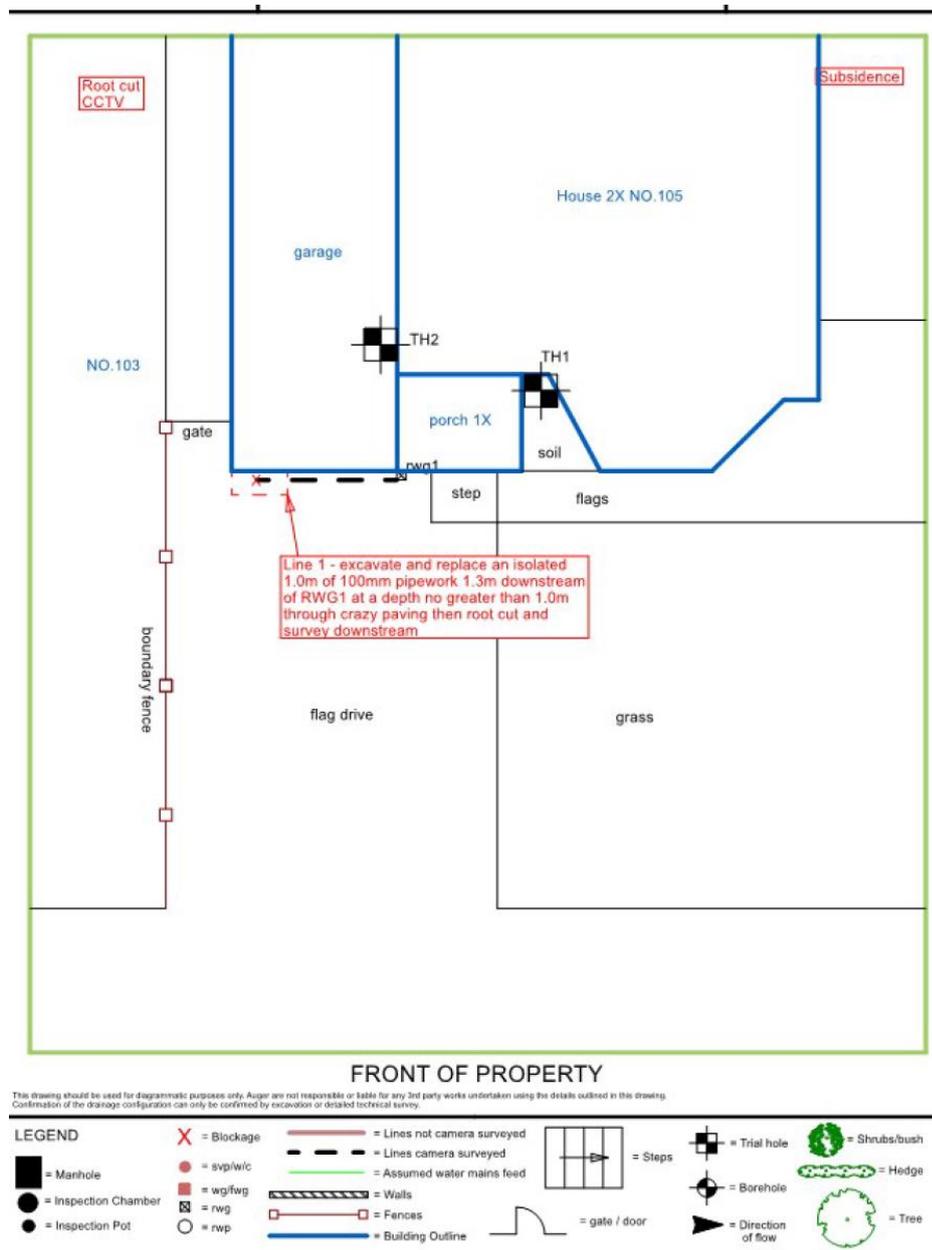
**Figure 4 - Site Plan**

- 6.4 The following supporting documents have been appended to the application:
- Engineer Appraisal Report (03.12.20)
  - Statement of reasons for works
  - Site investigation report (12.01.21)
  - Soil Analysis (08.02.21)
  - Level Monitoring (08.02.21)
  - Arboricultural Report (06.01.21)
- 6.5 Two boreholes (TP1/TP2) were excavated as part of the investigation. This revealed foundations to depths of 800mm in TP1 adjacent to the front porch and 600mm in TP2 adjacent to the garage/main dwelling. Root identification in the borehole reveals oak roots are beneath the foundations of the dwelling. Helical piling was installed circa 2017 and this has failed to achieve stabilisation.

- 6.6 Level monitoring results taken from 17 visits indicate movement associated with seasonal soil moisture loss. Movement is most severe at monitoring stations 2-6 positioned along the rear elevation of the conservatory.
- 6.7 Soil analysis has proven that the plasticity index is borderline medium - high, indicating an increased potential for volume change. Soil analysis indicates a plasticity index of between 50-59%.
- 6.8 The Engineer has recommended the trees be felled to remove the influence on the local soil conditions. The Arboricultural Consultant has agreed that tree felling is required.
- 6.9 A defective drain has been identified.
- 6.10 The estimated cost of underpinning and repair is from £80,000 with tree retention and £6000, should the influence of the tree be removed.
