PHYSICAL CONDITION SURVEY

WEST WICKHAM LEISURE CENTRE
STATION RD, WEST WICKHAM BR4 0PY

Oakleaf have undertaken a Physical Condition Survey of **West Wickham Leisure Centre** on behalf of London Borough of Bromley.

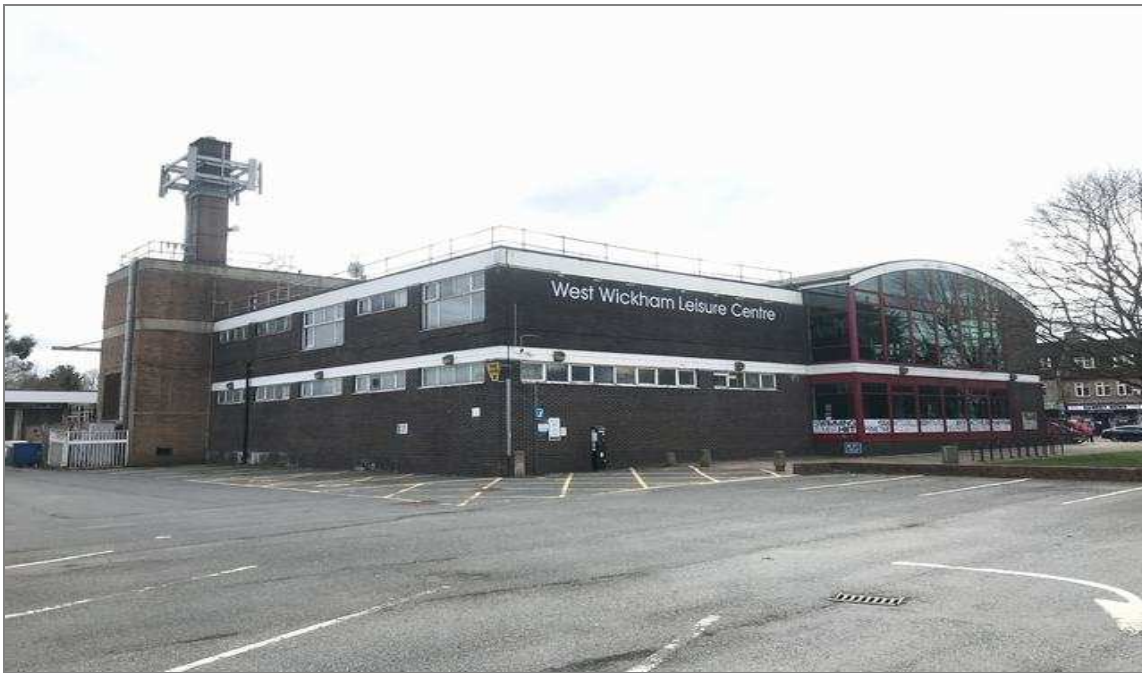
LBBR0059 West Wickham Leisure Centre Block 01 - Main Building

Build Year: 1967

Type of Construction: A three storey concrete framed building with various pitched and flat roofs.
