# PHYSICAL CONDITION SURVEY

WEST WICKHAM LIBRARY  
GLEBE WAY, WEST WICKHAM BR4 0SH

Oakleaf have undertaken a Physical Condition Survey of **West Wickham Library** on behalf of London Borough of Bromley.

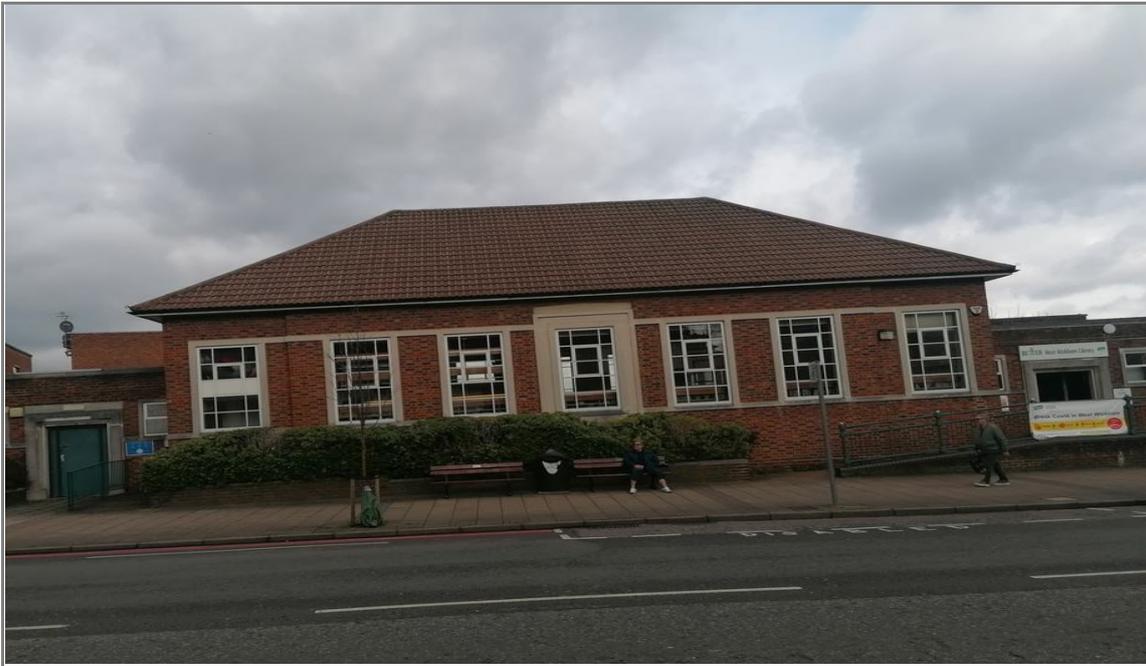
LBBR0119 West Wickham Library  
Block 01 - Main Building

**Build Year:** 1940

**Type of Construction:** A traditional brick built building with pitched roof.
