PHYSICAL CONDITION SURVEY

WEST WICKHAM LIBRARY
GLEBE WAY, WEST WICKHAM BR4 0SH

Oakleaf have undertaken a Physical Condition Survey of **West Wickham Library** on behalf of London Borough of Bromley.

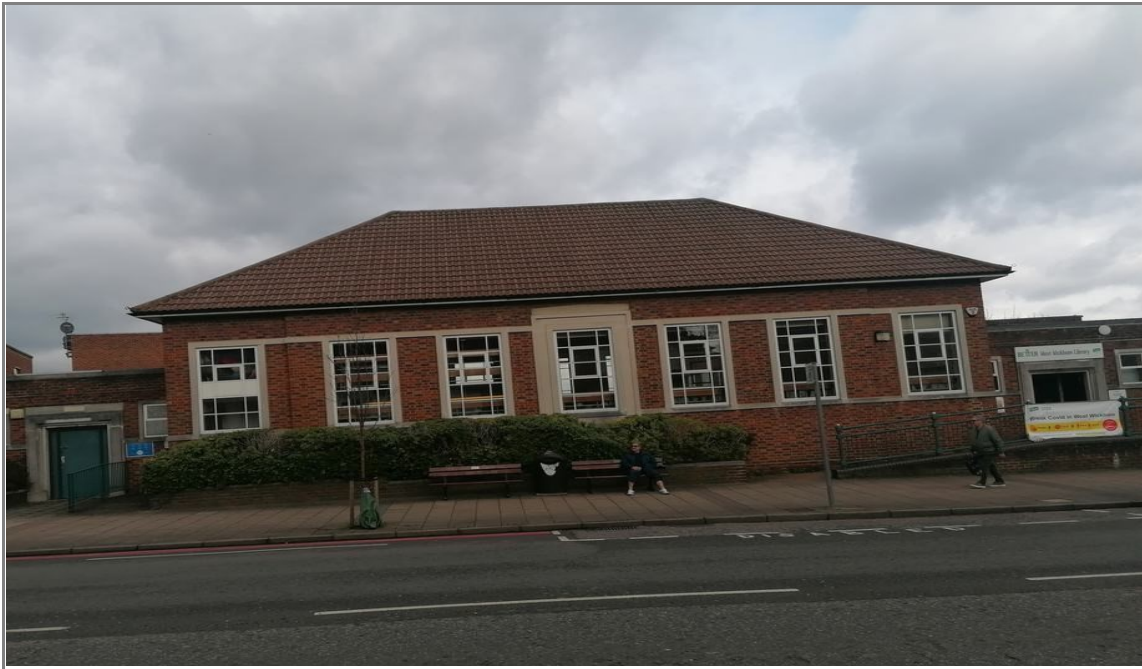
LBBR0119 West Wickham Library
Block 01 - Main Building

Build Year: 1940

Type of Construction: A traditional brick built building with pitched roof.
