CROYDON ROAD RECREATION GROUND BANDSTAND  
LONDON BOROUGH OF BROMLEY  
RIBA STAGE 3 ARCHITECTURAL PROPOSALS - DRAFT  
MARCH 2022

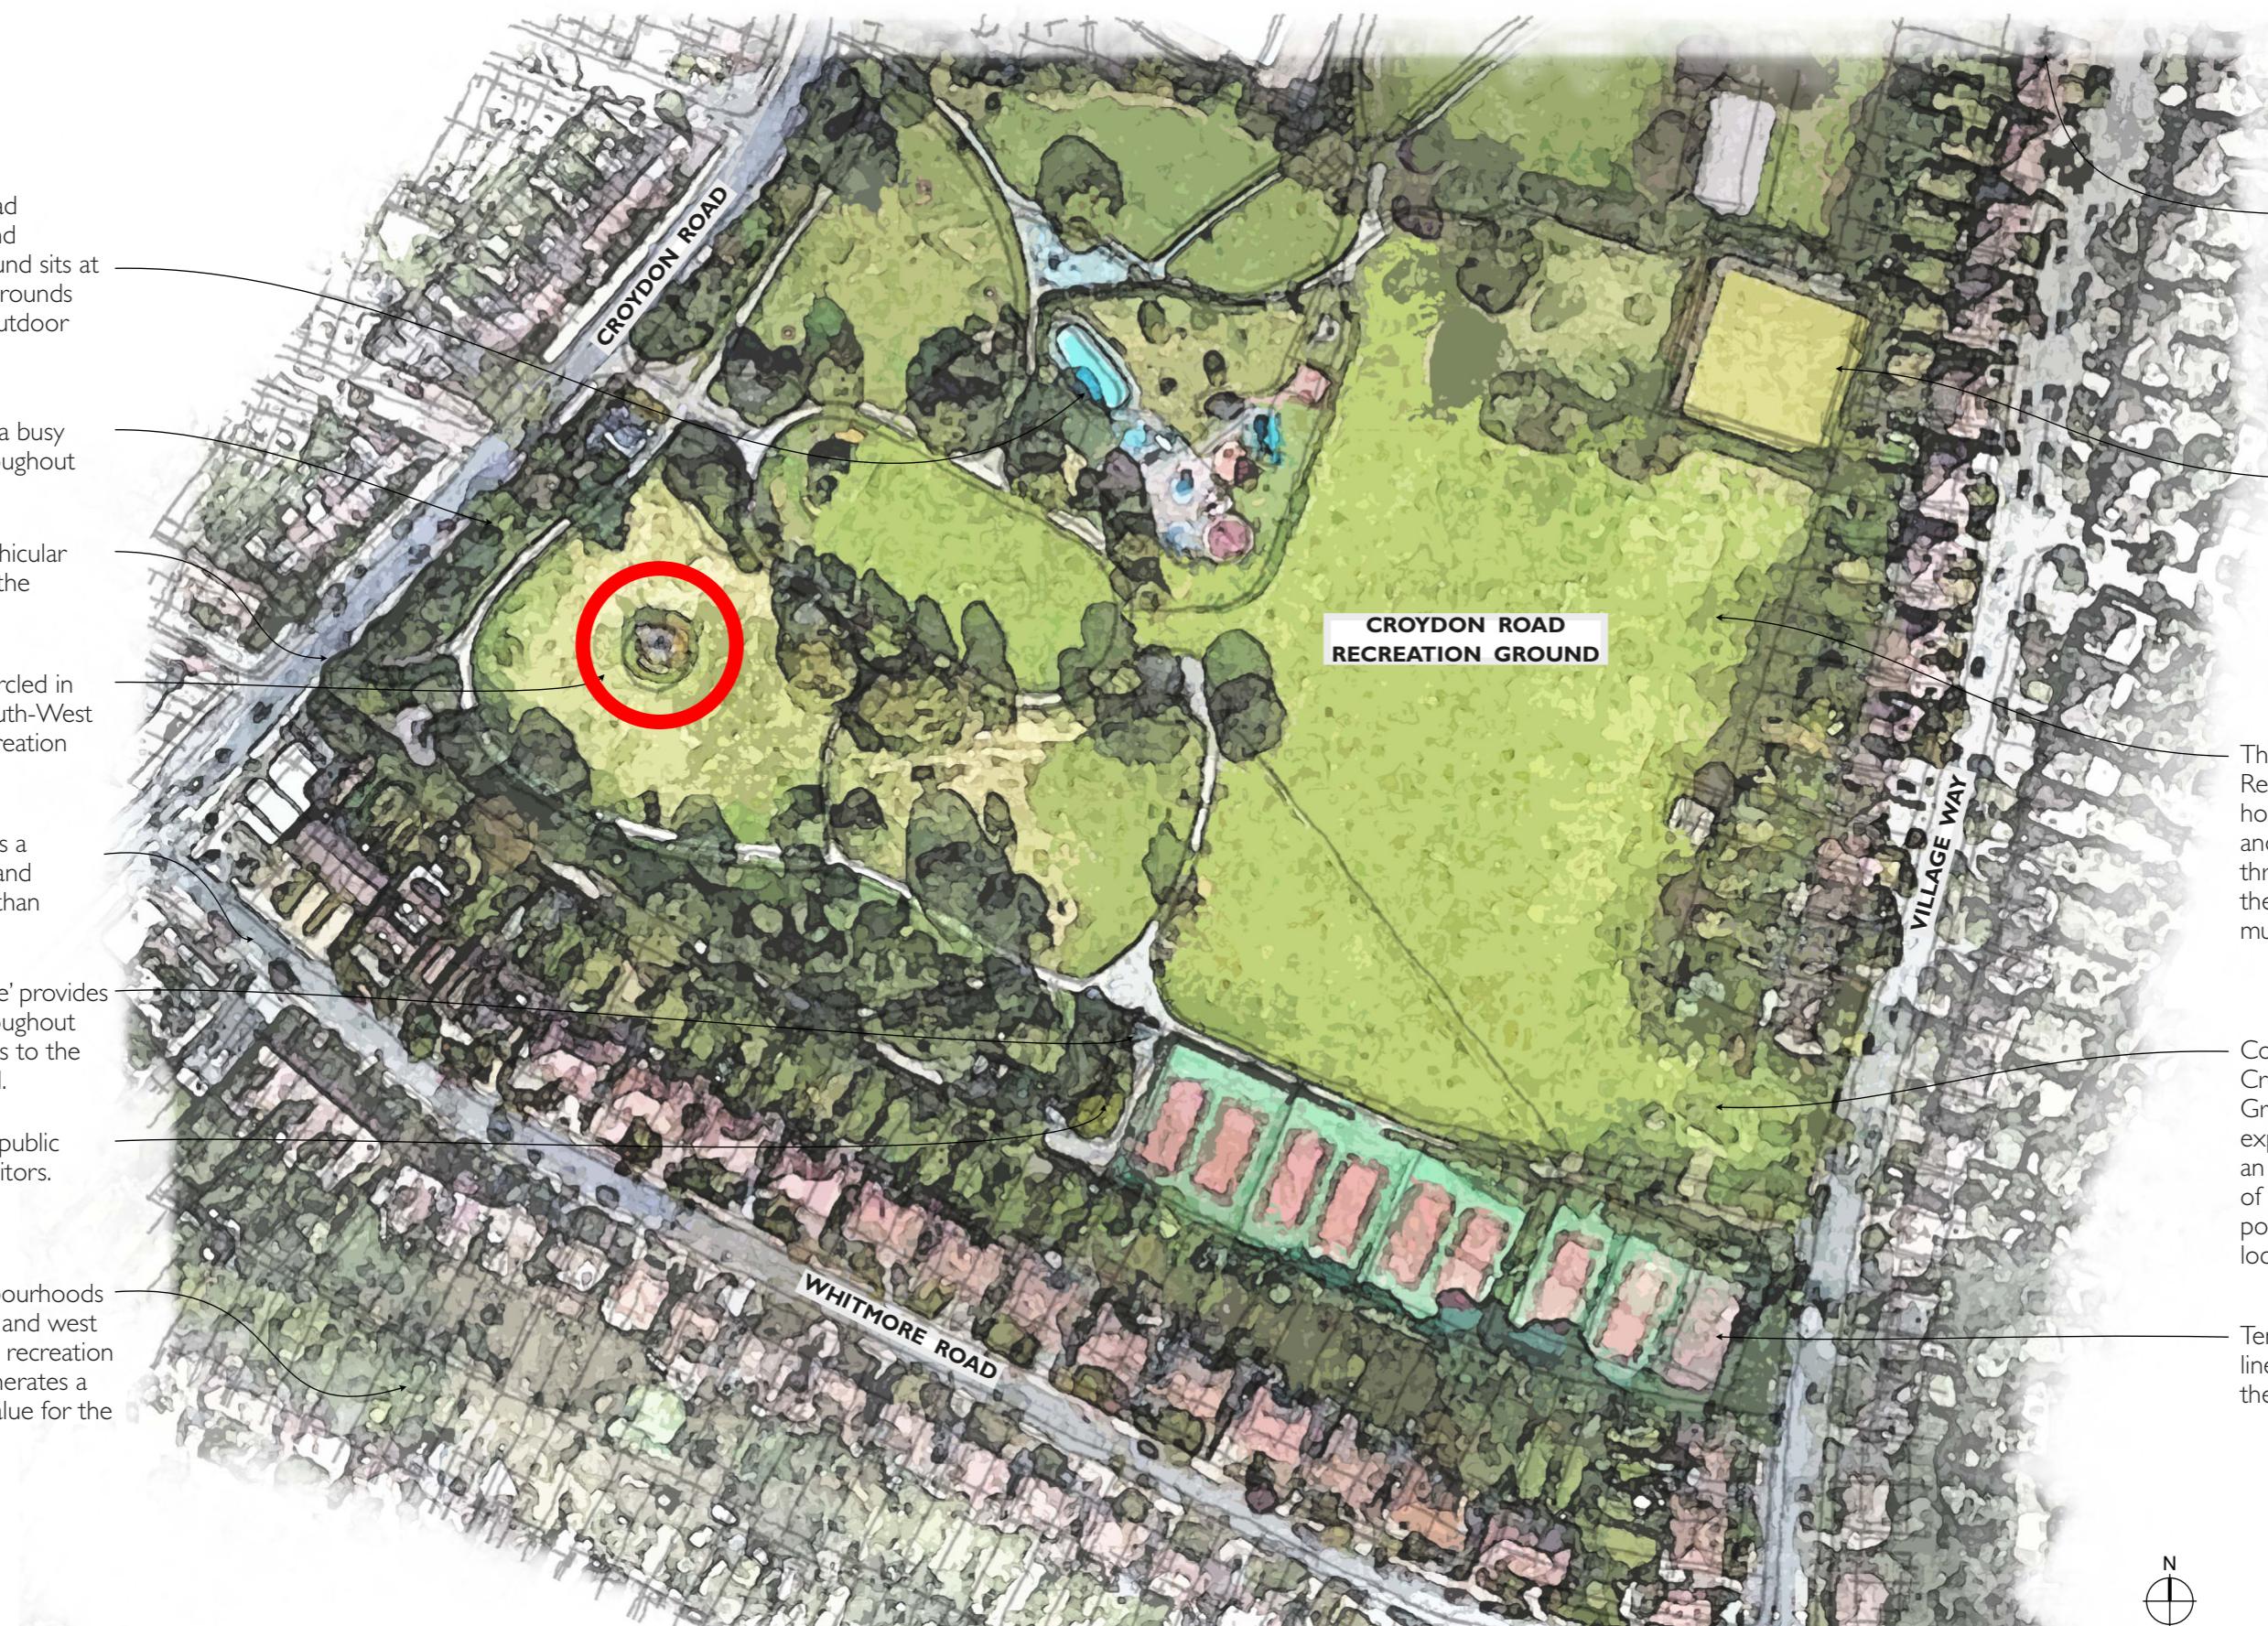
The Croydon Road Recreation Ground children's playground sits at the heart of the grounds and features an outdoor splash pool.

The Bandstand, circled in red, sits at the South-West corner of the recreation grounds.

The 'Beck Rec cafe' provides refreshments throughout the year to visitors to the recreation ground.

Male and Female public toilet block for visitors.

Beckenham Bowling Green providing social amenities for the local community.

Tennis courts, for public use, line the south-east corner of the grounds.

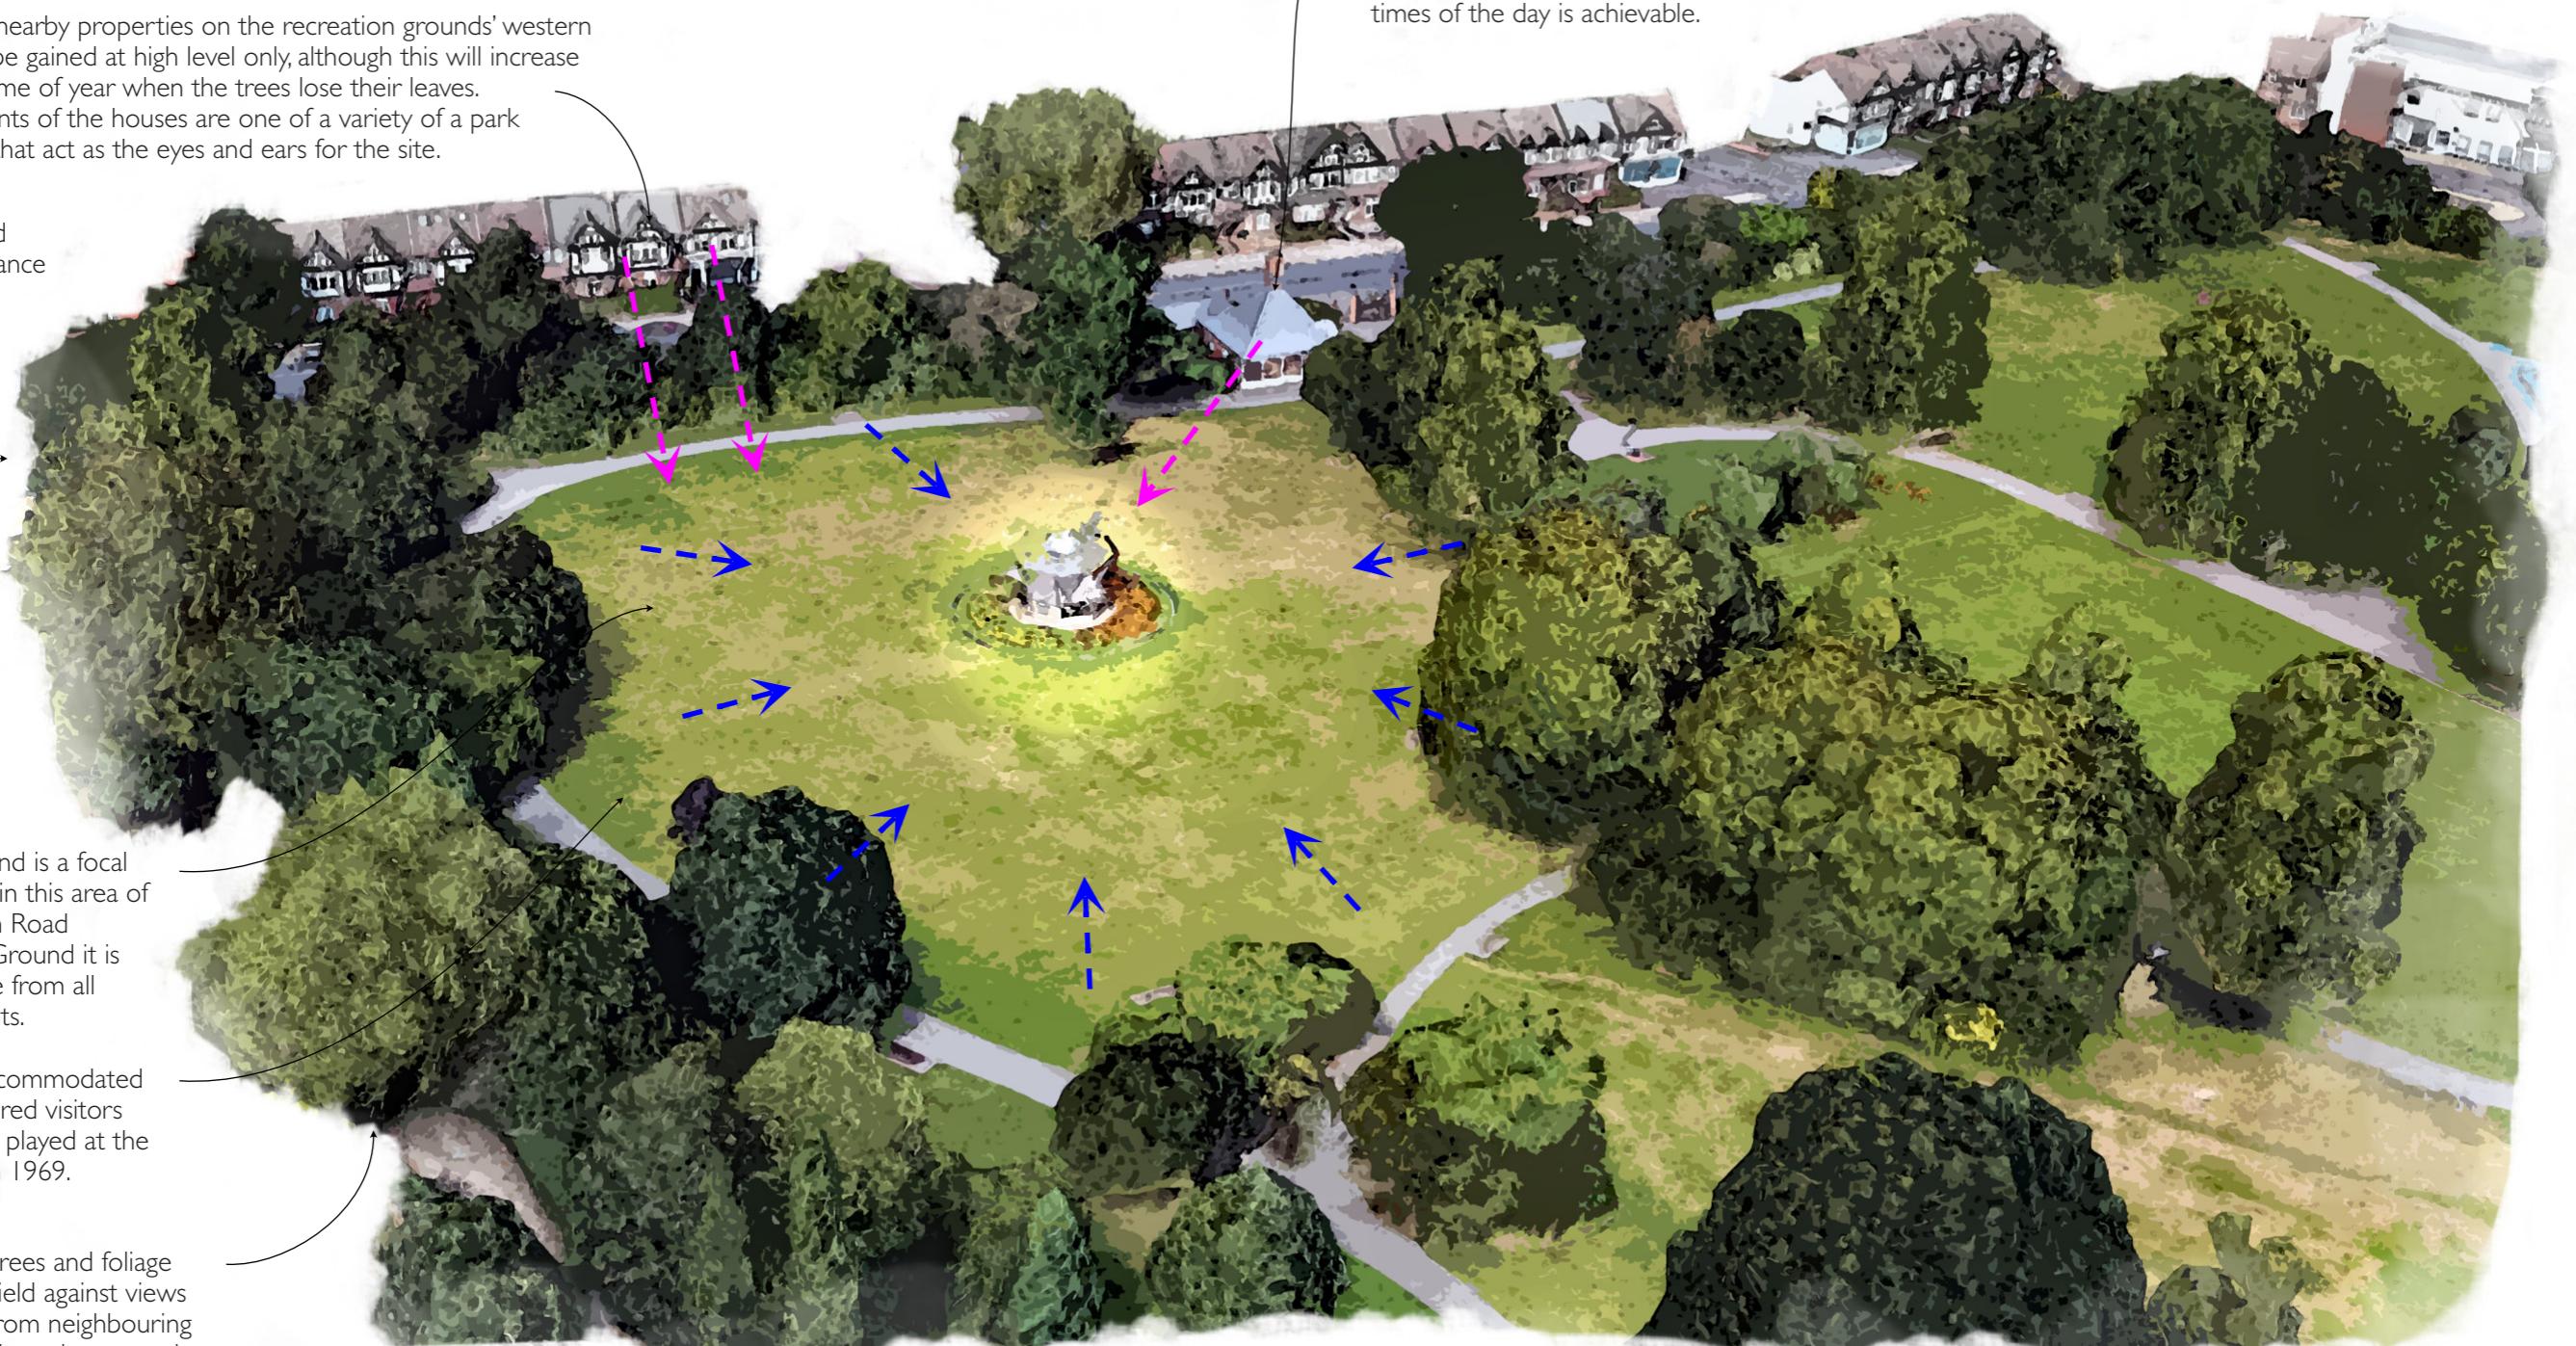
With established trees and foliage lining the west and south boundaries of the recreational grounds, external visibility of the Bandstand is limited. During late autumn through to winter, this aspect changes slightly when the trees lose their leaves and obstructed views are permitted. The Bandstand itself sits proudly in the centre of its landscape, acting as the focal point for visitors entering and staying within the grounds and is therefore highly visible.

Views from nearby properties on the recreation grounds' western border can be gained at high level only, although this will increase during the time of year when the trees lose their leaves. The inhabitants of the houses are one of a variety of a park community that act as the eyes and ears for the site.

The Bandstand is a focal point. Once in this area of the Croydon Road Recreation Ground it is clearly visible from all vantage points.

Established trees and foliage provide a shield against views and access from neighbouring properties along the recreation grounds' southern border.

With this property inside the grounds now inhabited, good visibility of the Bandstand at all times of the day is achievable.

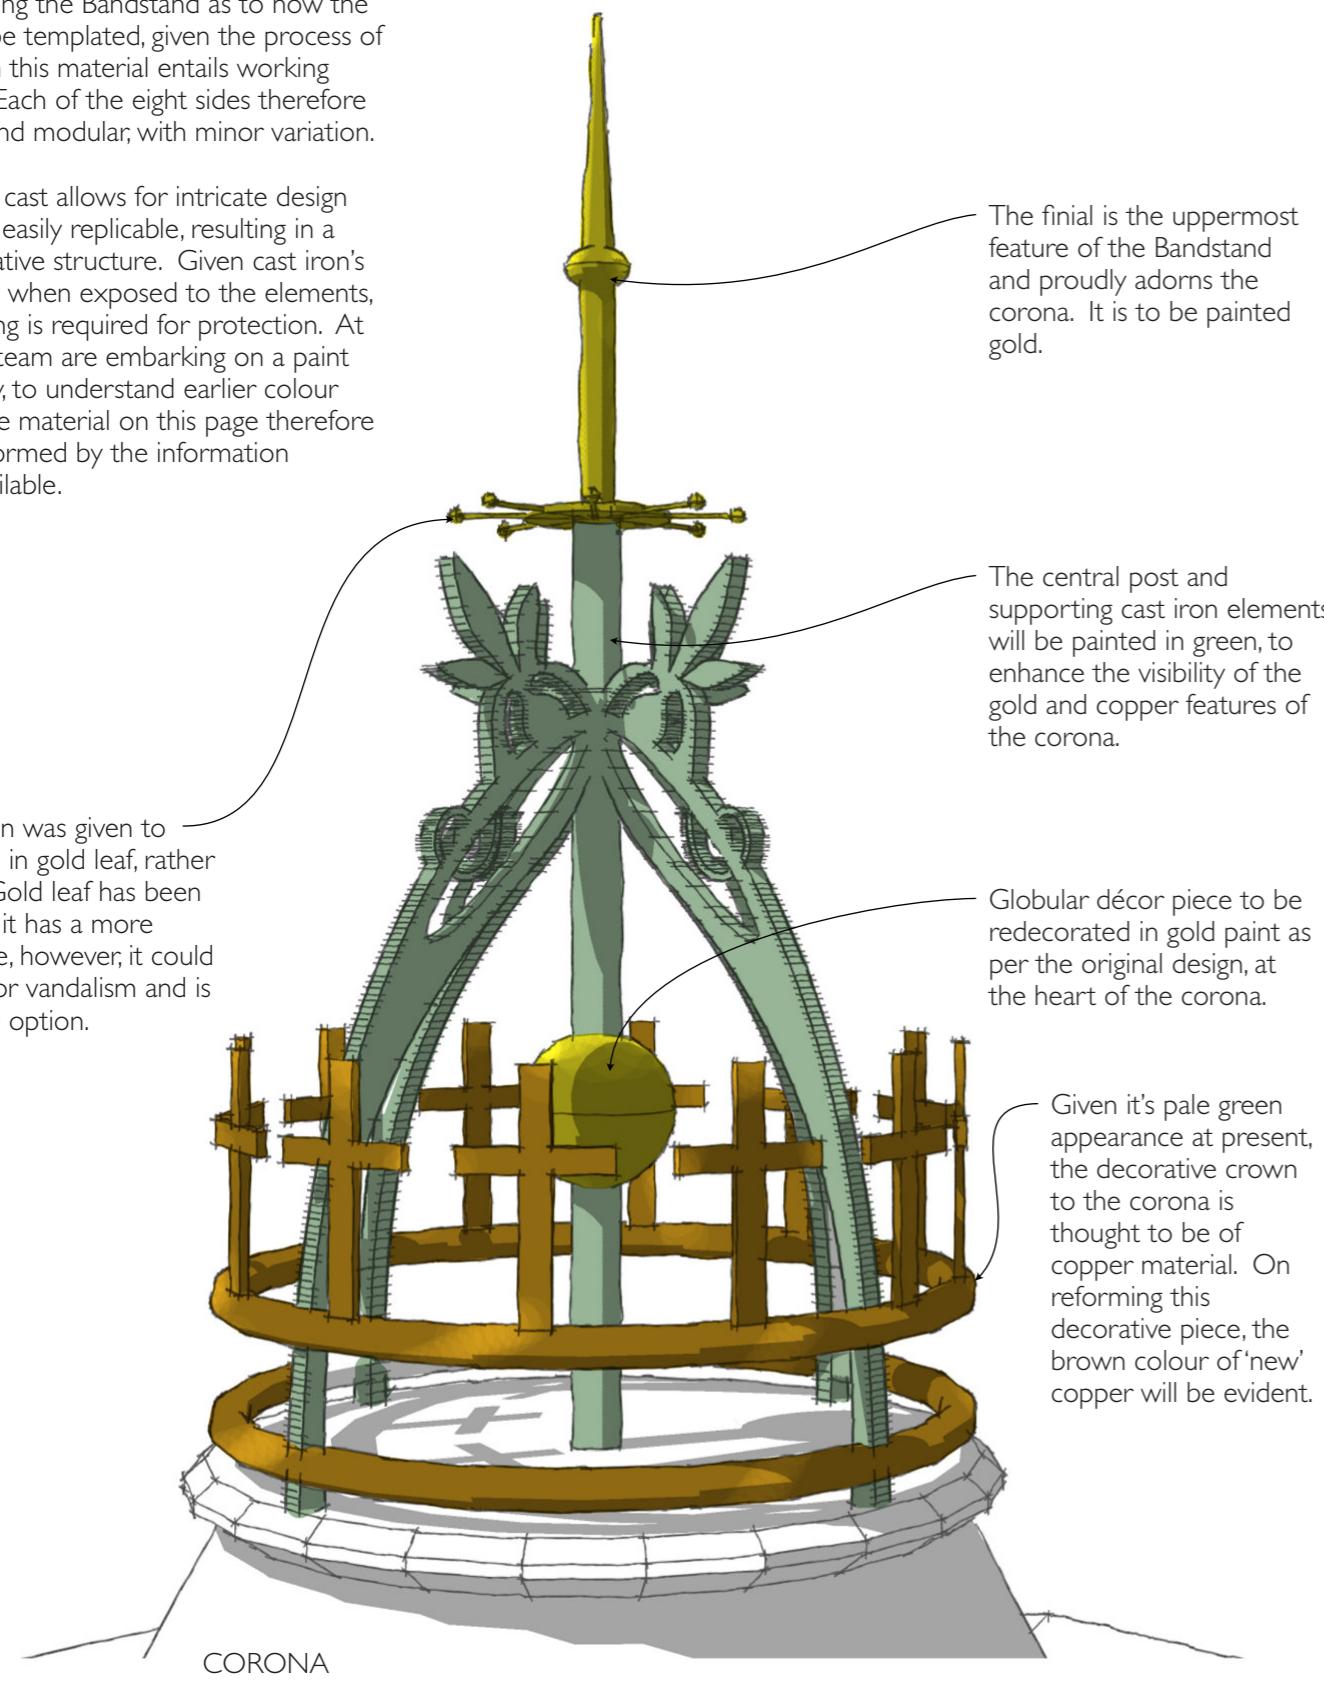
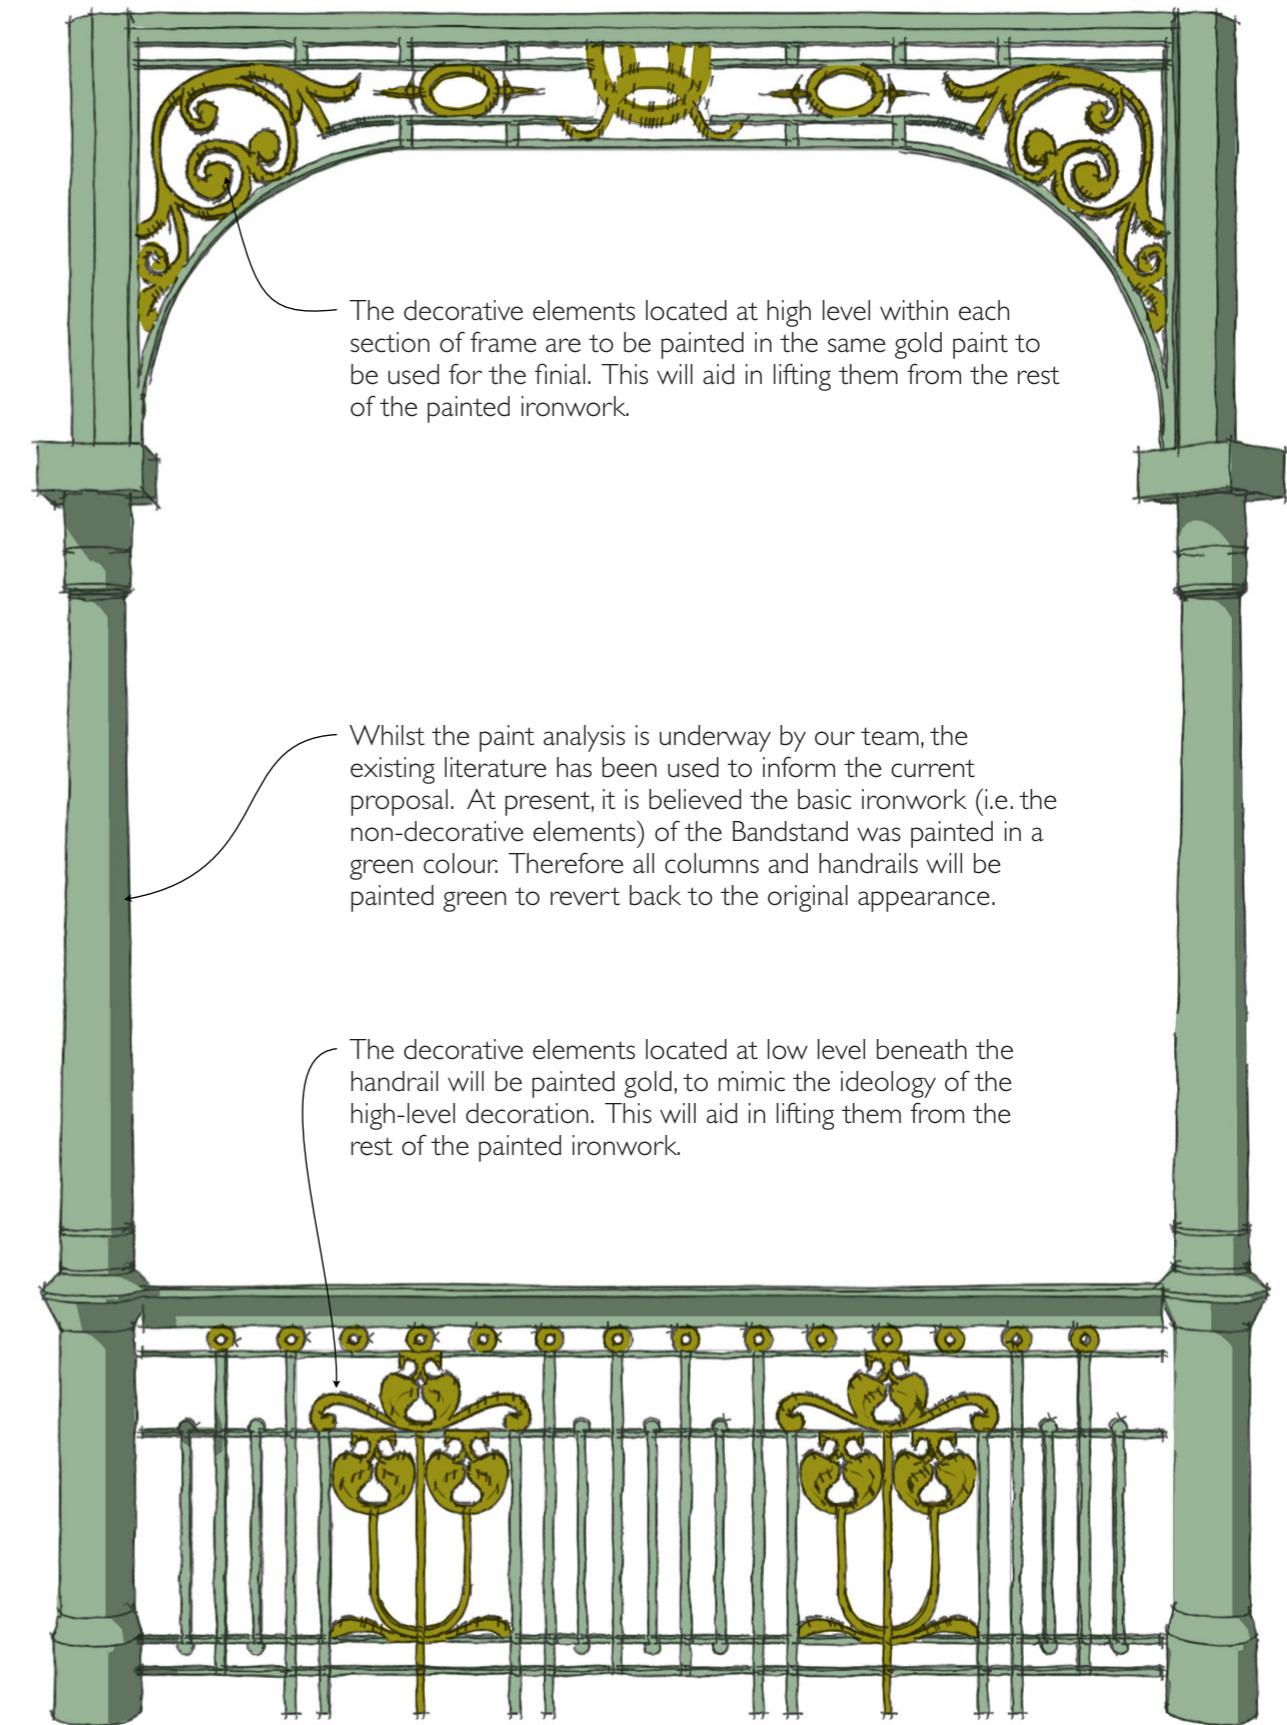
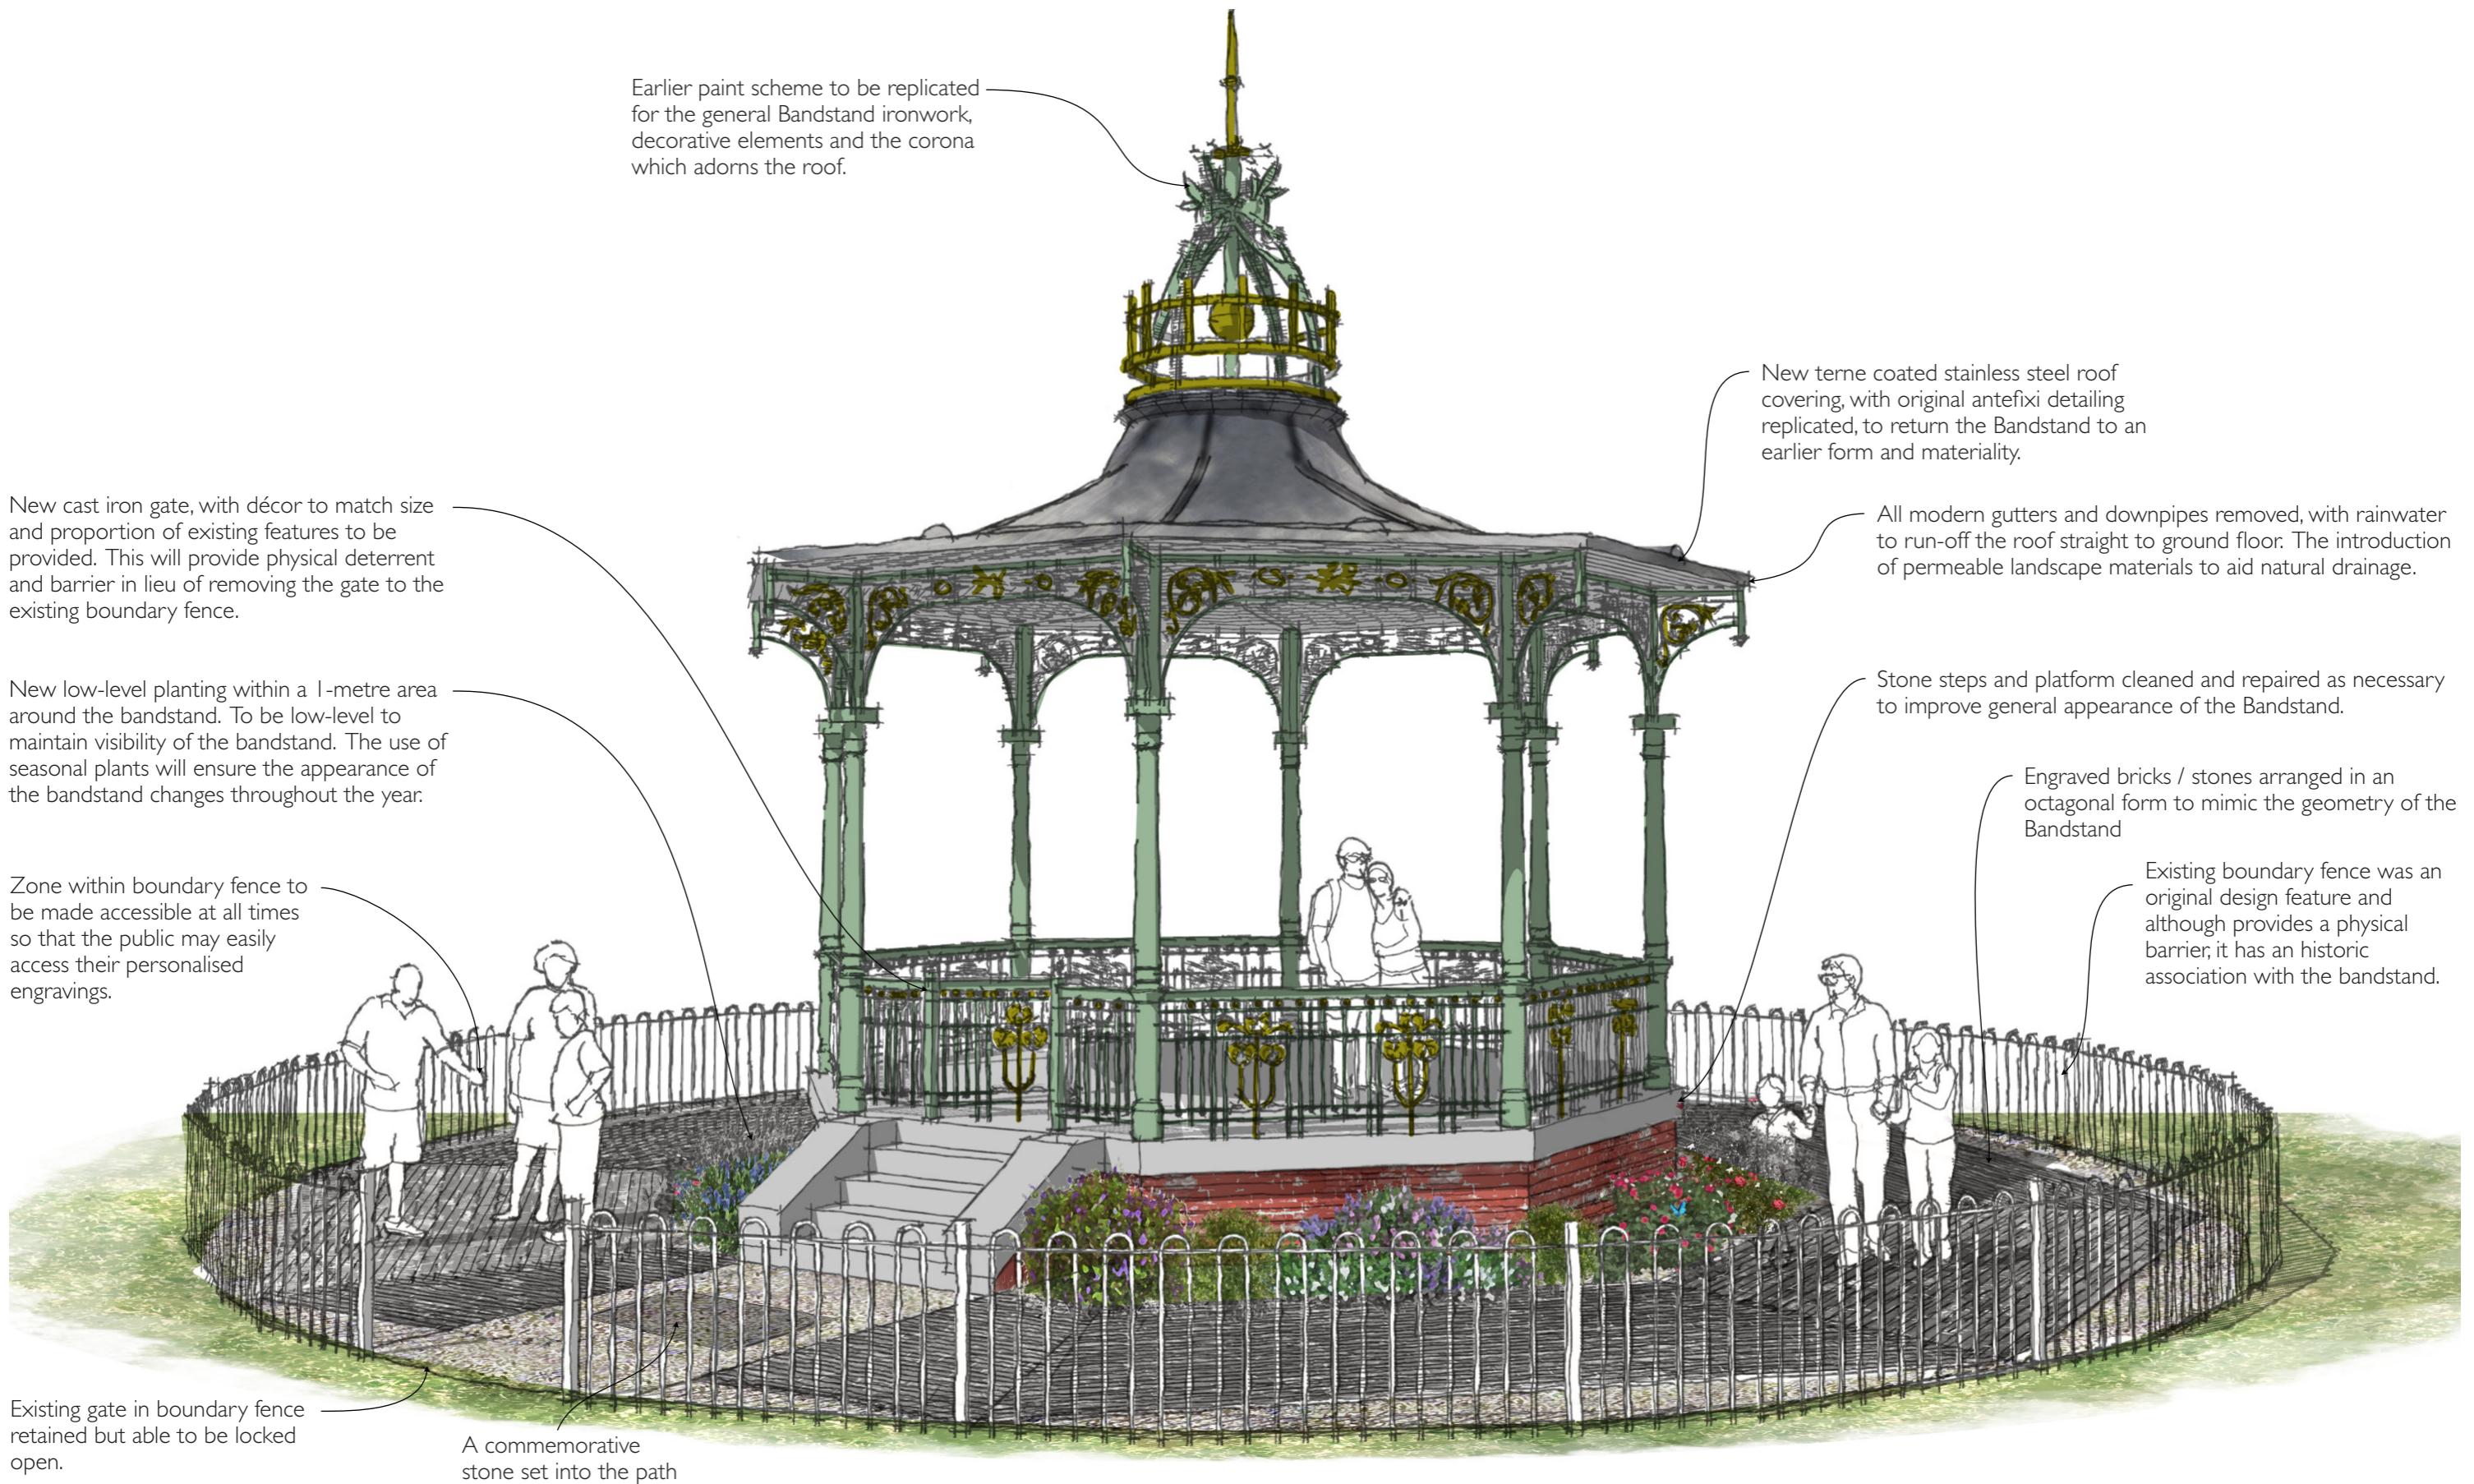
As a cast iron structure, thought was given when designing the Bandstand as to how the form could be templated, given the process of working with this material entails working with a cast. Each of the eight sides therefore are regular and modular, with minor variation.

The use of a cast allows for intricate design details to be easily replicable, resulting in a highly decorative structure. Given cast iron's performance when exposed to the elements, a paint coating is required for protection. At present, the team are embarking on a paint analysis study, to understand earlier colour schemes. The material on this page therefore has been informed by the information currently available.
