Appendix A: Kelsey Park Replacement Bridges (Options Appraisal)

London Borough of Bromley
Report No ES20224 Kelsey Park Replacement Bridges (Options Appraisal)

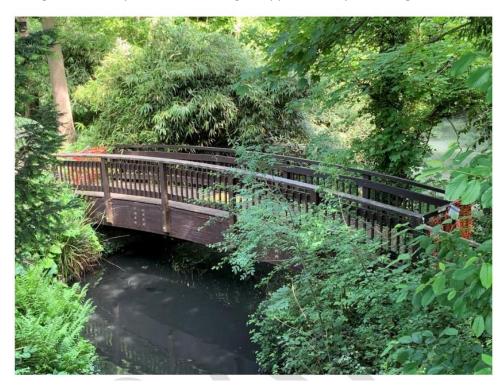
Footbridge A provides pedestrian access across a shallow stream and is located at the north end of the large lake in the park. The footbridge is approximately 9.7m long and 1.9m wide.

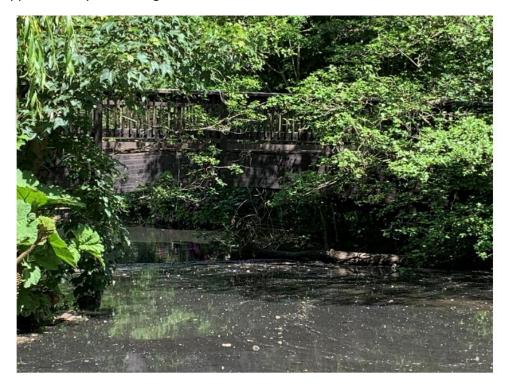
Footbridge B provides access across the southern section of the Lake in Kelsey Park. It is approximately 17.6m long and 2m wide.

Committee Report ES20224 recommends that the Council proceeds with *Option 2* presented within whereby Footbridge B is replaced with a like for like timber structure. This solution would be an all-timber footbridge with the design features that include:

- Ekki hardwood dowel laminated beams
- The footbridges to be cambered on a continuous vertical curve.
- A deck composed of Ekki deck planks treated with a non-slip system called Hi-Grip Excel (two strips of resin/bauxite inserted into grooves of deck).
- Parapets with a height of 1.4m also made of timber Ekki with vertical infill spindles.
- All timber to be hardwood and with natural finishes.
- A similar feature of natural wood as the current footbridge.

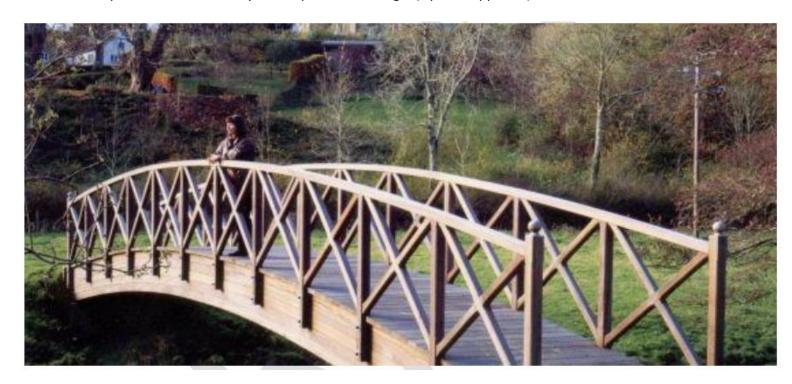
An example of a similar bridge is shown in the below image, however please note that there is no specific requirement for aesthetics within this project.
